**COMMISSION OF INQUIRY INTO THE DIAPHRAGM WALL AND PLATFORM
SLAB CONSTRUCTION WORKS AT THE HUNG HOM STATION EXTENSION
UNDER THE SHATIN TO CENTRAL LINK PROJECT**

**WITNESS STATEMENT OF MA MING CHING DEREK
FOR
MTR CORPORATION LIMITED**

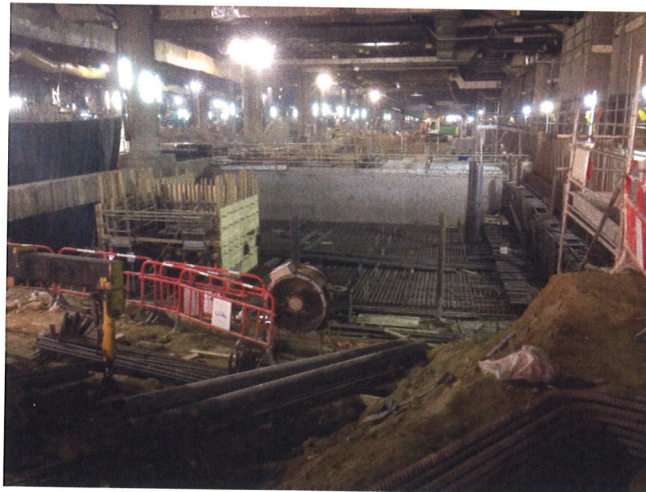
Image 1: Bottom layer rebars in Area C1 of EWL slab (West)
