**COMMISSION OF INQUIRY INTO THE DIAPHRAGM WALL AND PLATFORM  
SLAB CONSTRUCTION WORKS AT THE HUNG HOM STATION EXTENSION  
UNDER THE SHATIN TO CENTRAL LINK PROJECT**

**SECOND WITNESS STATEMENT OF MA MING CHING DEREK  
FOR  
MTR CORPORATION LIMITED**

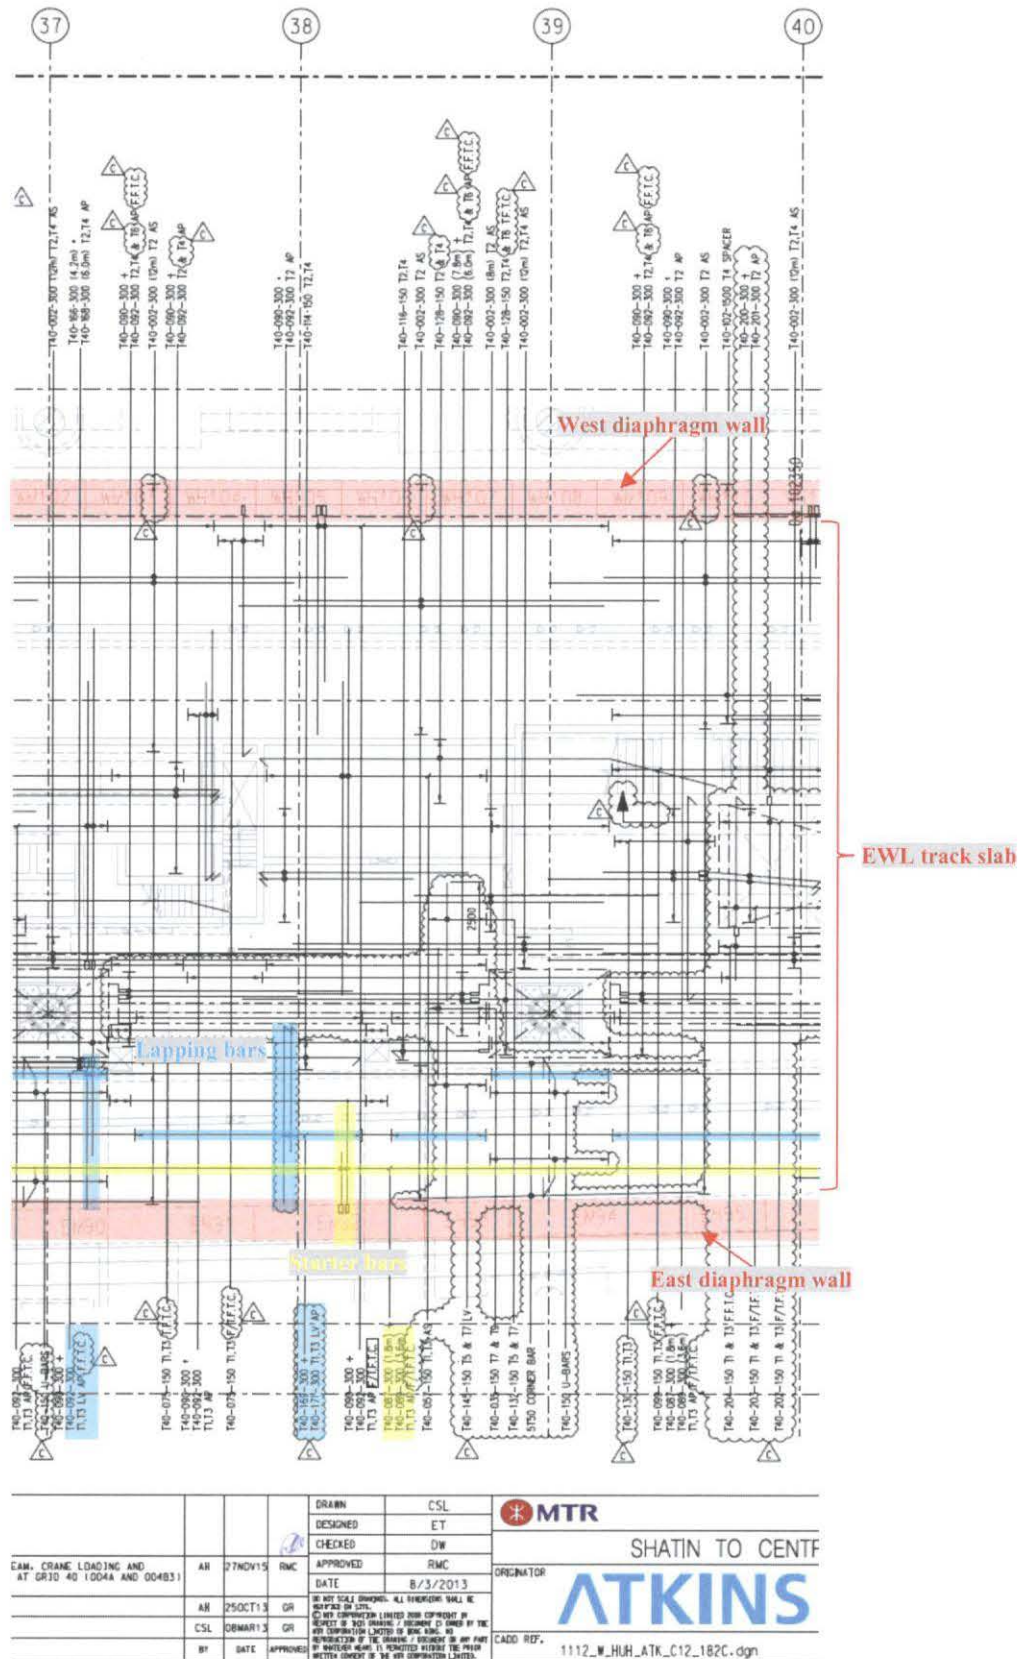
Image 1: drawing 182C (Area C2-6) [B5/B2833]

8. These working drawings show the original design intent with starter bars connected to two layers of cast-in couplers at the top of the east diaphragm wall, and these starter bars would be lapped with two corresponding layers of top mid-span rebars extending from the middle of the EWL track slab up to the east diaphragm wall. For ease of reference and in order to assist the Commission of Inquiry to understand what the working drawings show, I have added highlights and annotations in the extracts above:

- 8.1. The yellow highlights in the extracts above indicate the two layers (T1 and T3) of starter bars to be connected to the top couplers of the east diaphragm wall. This reinforcement detail applies along the length of the diaphragm wall, following the horizontal line in the extracts which is similarly highlighted in yellow.

- 8.2. The blue highlights in the extracts above indicate the two layers (T1 and T3) of top mid-span rebars which would extend transversally from the middle of the EWL track slab up to the east diaphragm wall. These mid-span rebars would be lapped with the starter bars connected to the top of the east diaphragm wall. Again, this reinforcement detail applies along the length of the diaphragm wall, following the horizontal line in the extracts which is similarly highlighted in blue.

- 8.3. As can be seen from the working drawings, the transverse top mid-span rebars and the top starter bars were all arranged in alternate lengths, such that a long mid-span rebar/starter bar would always be placed next to a short mid-span rebar/starter bar and vice versa. This means that the lapping of the mid-span rebars with the starter bars would be staggered across the length of the relevant bay.

9. Accordingly, it is clear that the original design intent as reflected in working drawing 182C [B5/B2833] consists of transverse mid-span rebars at the top of the EWL track slab (arranged in alternate lengths) extending up to the east diaphragm wall, and these mid-span rebars would be lapped with the starter bars (also arranged in alternate lengths) connected to the top couplers in the east diaphragm wall. This would achieve the staggered lapping of the mid-span rebars with the starter bars across the length of the EWL track slab and diaphragm wall.

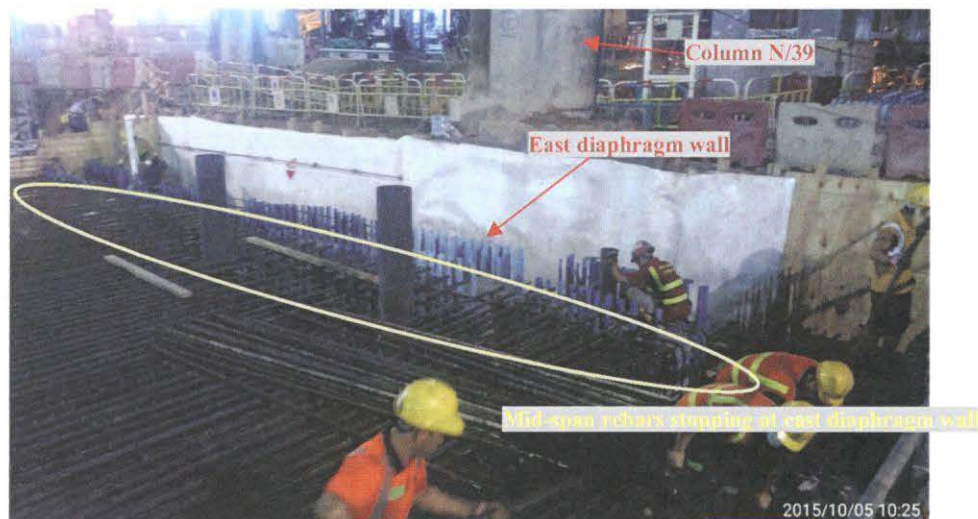
Image 2: site photo disclosed by China Technology at [D1/D607]

5. I understand from the hearing transcript at [Day 11/83/1–Day 11/86/8] that, in summary:
  - 5.1. Mr Poon alleged that *'for the lapping bars, they must not be placed casually. We must place them in low tensile zones'*, and that the photo at [D1/D607] *'shows the failure of the bar reaching the end of the slab. They basically stop at the diaphragm wall'*. The photos were alleged by Mr Poon to have been taken in Area C2-3 or Area C2-6.

- 11.1. The photos at [D1/D607-D608] (Images 2 to 3 below) appear to show ongoing rebar fixing works in Area C2-6 (and not Area C2-3) between gridlines 38 and 40, with column N/39 in the background. The blue vertical bars shown in the photo indicate the location of the top of the east diaphragm wall (after the top 400 to 500 mm of concrete has been trimmed off). Contrary to what Mr Poon suggested, this photo simply shows the fixing of the top mid-span rebars extending up to the east diaphragm wall (circled in yellow), that is, prior to the fixing of the through bars and the lapping of those through bars with the mid-span rebars.

12. Finally, I should point out that the site photos at [D1/D607-D609] all seem to be taken on 5 October 2015 at various times of the day, and concrete was ultimately poured in Area C2-6 on 7 October 2015 [B5/B2902]. It is therefore unremarkable that the photos taken by China Technology on 5 October 2015 show rebar fixing works which were still in progress at the time.

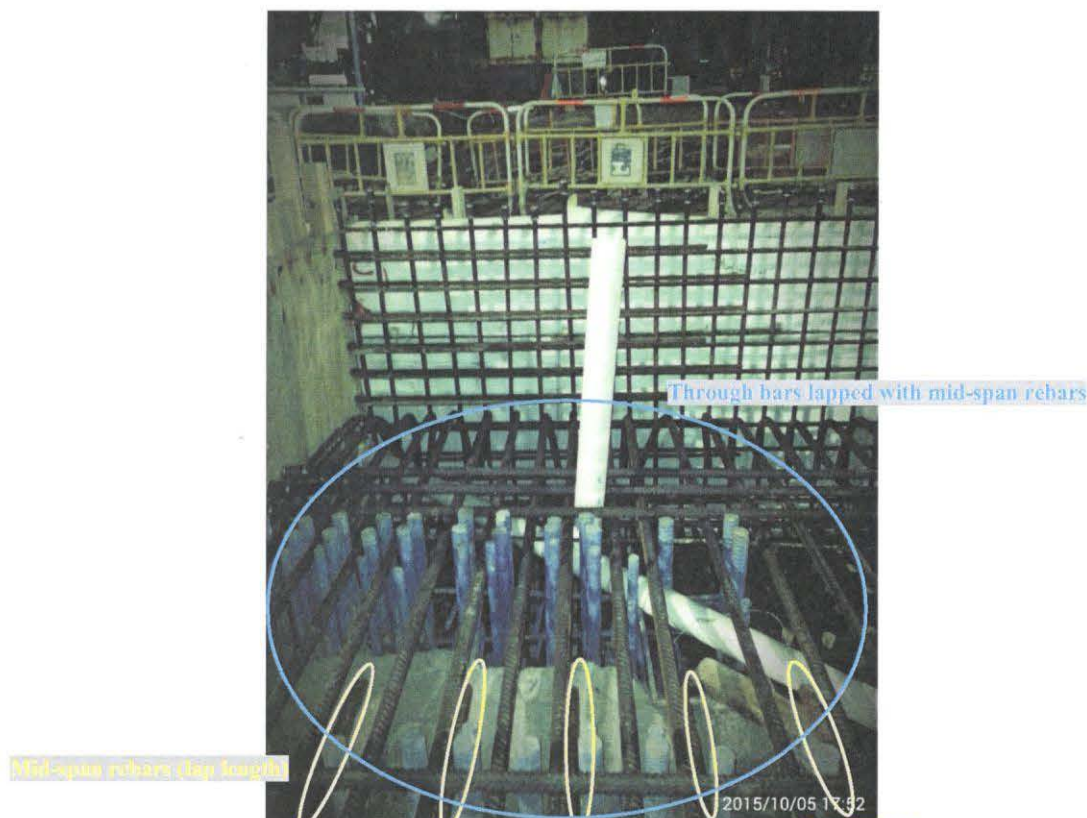
Image 4: site photo disclosed by China Technology at [D1/D609]

- 5.2. Further, Mr Poon alleged that, with reference to the photo at [D1/D609], *'we have through-bars, about 300 metres, you see the lap or the lapping. Then, for the shorter bar down there (indicating), that's the bar fixing works; we see in D607 they stop on the retaining wall. Then for the bars at the EWL track slab, there is a starter bar there, so I can be sure that this is not the through-bar referred to by MTRC. Actually, the bar has been broken up. So there shouldn't be a short bar here, if we did have the through-bar. The through-bar should extend all the way from here to the very end'*.

11.2. The photo at [D1/D609] (Image 4 below) appears to show a close-up view of the rebars at the top of the east diaphragm wall. The blue vertical bars shown in the photo again indicate the location of the top of the east diaphragm wall (after the trimming off of the top 400 to 500 mm of concrete). Contrary to Mr Poon's allegations, this photo in fact shows the top mid-span rebars extending up to the east diaphragm wall (circled in yellow), alternately lapped with through bars (circled in blue) which extend from the EWL slab across the top of the diaphragm wall into the Over Track Exhaust ("OTE") slab. Therefore, it is incorrect to say that this photo shows 'a short bar' or that 'the bar has been broken up', and this photo actually confirms the staggered arrangement of the lapping rebars as per the design intent reflected in working drawing 182C [B5/B2833].

11.3. Although I can see from the photo at [D1/D609] (Image 4 below) that the mid-span rebars appear to extend slightly into the diaphragm wall rather than stop at the edge of the diaphragm wall, this was simply because the mid-span rebars were cut to a slightly greater length than was required by the working drawings. The excess length was not an issue as long as the required minimum lap length was achieved (as measured from the edge of the excavation side of the diaphragm wall, in accordance with the working drawings).<sup>1</sup>
