Interim Report of Commission of Inquiry into the Construction Works at and near the Hung Hom Station Extension under the Shatin to Central Link Project

(The Redacted Version)

February 2019

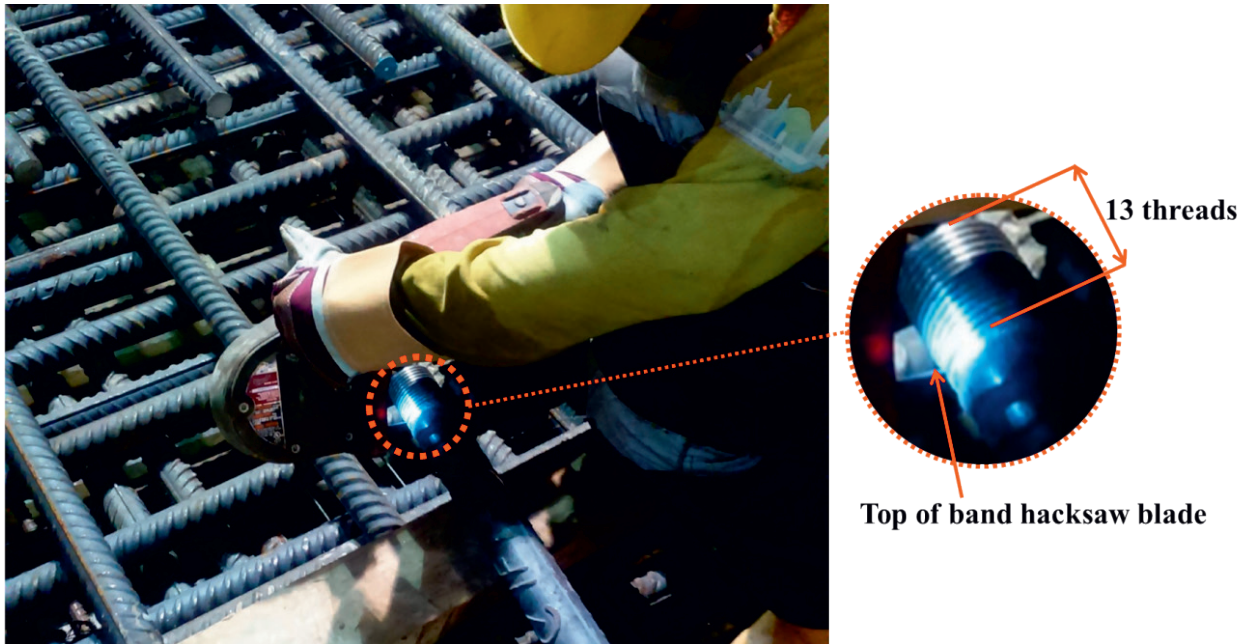
Photograph 1

69. During the course of the Commission hearings, there was evidence that it may have been an occasional practice, if for any reason Type A rebars were in short supply on site, to convert Type B rebars to Type A rebars by cutting away the ‘excess’ threads. While (understandably) this was not a practice recommended by BOSA, provided the shortened threads could be screwed into a coupler, the Commission is satisfied it would not have presented any safety risk.

¹⁴ This photograph was one of three or four photographs taken one evening by Jason Poon showing the cutting of threads and almost immediately thereafter the installation of what may well be the same rebar into the diaphragm wall.

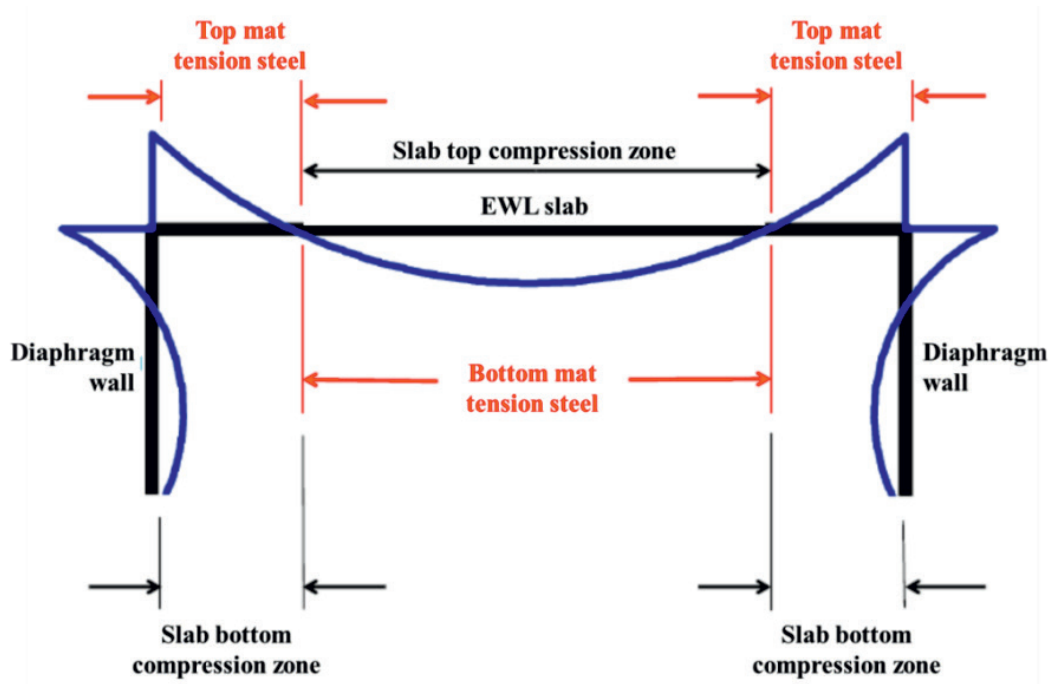
Diagram 11

340. The Commission was advised by the experts that, in order to comply with the Code, the amount of reinforcement steel in the bottom of the EWL platform slab needed to be at least equivalent to 50% of the reinforcement steel in the top of the slab.

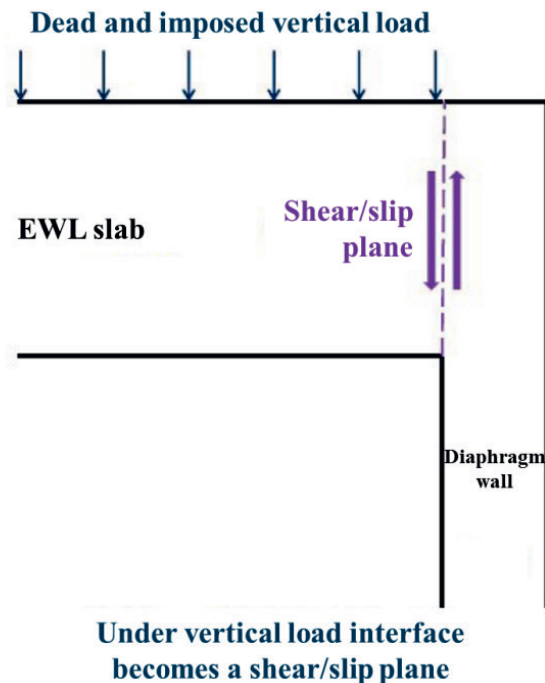
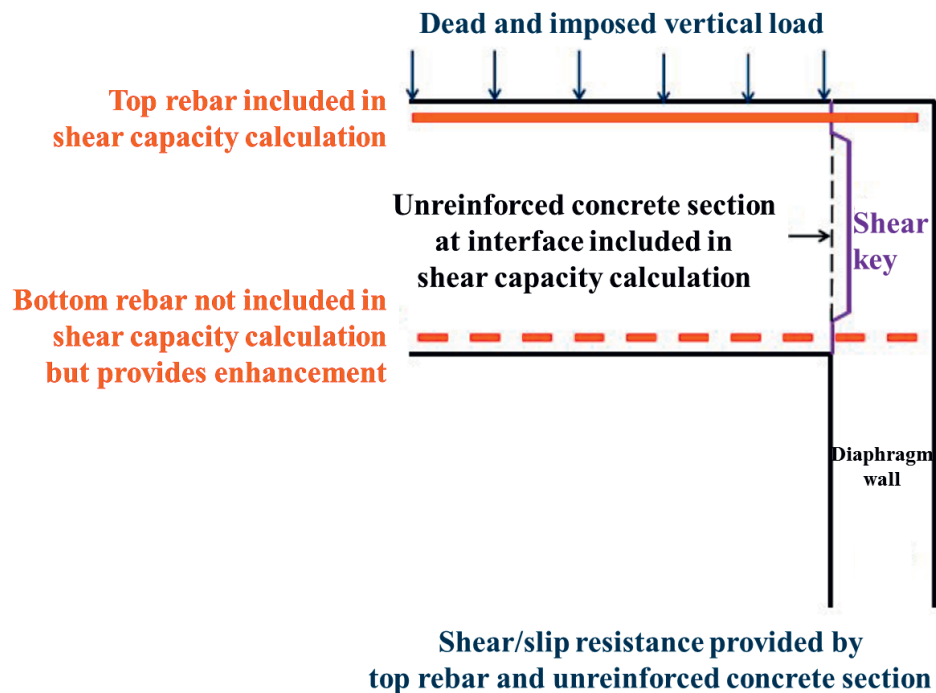
diaphragm wall) resists shear forces at the interface between the slab and the diaphragm wall.

“All agreed that irrespective of the code requirement the EWL slab does not, in theory, rely on steel at the interface, at the bottom, for flexure and shear capacity.”
