**COMMISSION OF INQUIRY INTO THE DIAPHRAGM WALL
AND PLATFORM SLAB CONSTRUCTION WORKS
AT THE HUNG HUM STATION EXTENSION UNDER THE
SHATIN TO CENTRAL LINK PROJECT**

CLOSING SUBMISSIONS FOR LEIGHTON

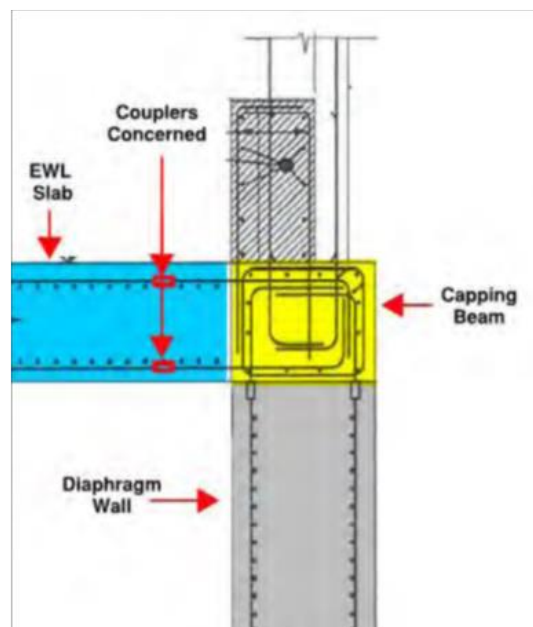
21. The only suitable measures proposed to be carried out in the HUH Extension with respect to coupler connections is in a section of the Area A of the EWL slab approximately 500mm away from the east D-wall into the EWL slab, illustrated as follows:-

for COI-1,¹⁰ a strength reduction factor of 68.3% was adopted for the coupler connections in Area A of the EWL slab.¹¹ According to Atkins' calculation, this means that the section is understrength and therefore needs to be strengthened.

23. This was despite NO physical investigation work being carried out in Area A,¹² nor any evidence being obtained to show there are any defective coupler connections in that area.

24. The figure was derived from a very small sample size, **all derived from Area HKC of the EWL slab**: specifically, 11 samples on the capping beam side (2 failed), and 7 samples on the platform slab side (2 failed).¹³

25. There is no justification to rely on the very limited evidence of coupler defects found in Area HKC of the EWL slab and to extrapolate them to infer that Area A has similar defects, particularly when Area A was built in May to July 2015, almost one year before Area HKC was built in July to August 2016, and by different subcontractors.¹⁴

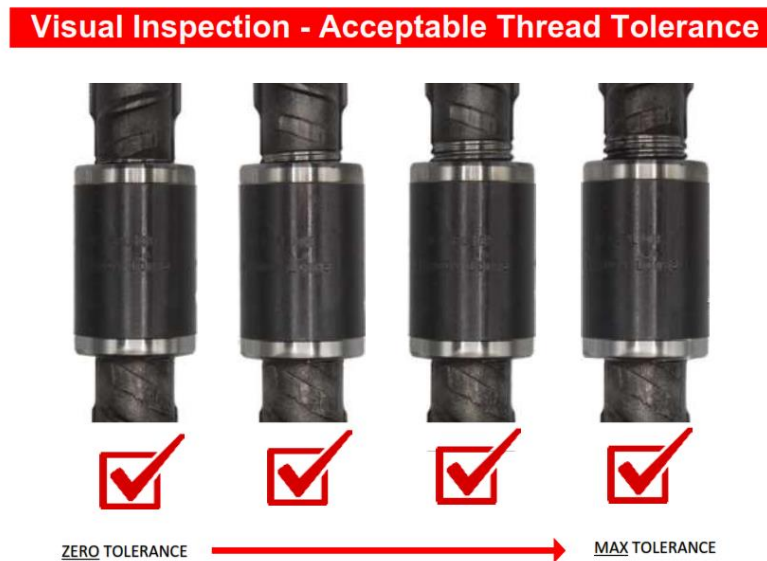
33. BOSA’s guideline for workers in the field (as shown below) does not refer to a “butt-to-butt” requirement, and focuses on a visual inspection to ensure a maximum of two full threads exposed:-²³

SUMMARY:

1. After connection has been fully tightened, one should see a maximum of TWO FULL THREADS to ensure a proper installation.
2. Please refer to our SEISPLICE Technical and Quality Assurance Manual Dimensions table for our thread length tolerance. Appendix 4 of our Coupler Specifications.
3. Under normal circumstances, we provide a positive tolerance of half a thread.
4. As illustrated in the above scenario, the exposed thread, if any, always occurs at the top of the continuation bar.

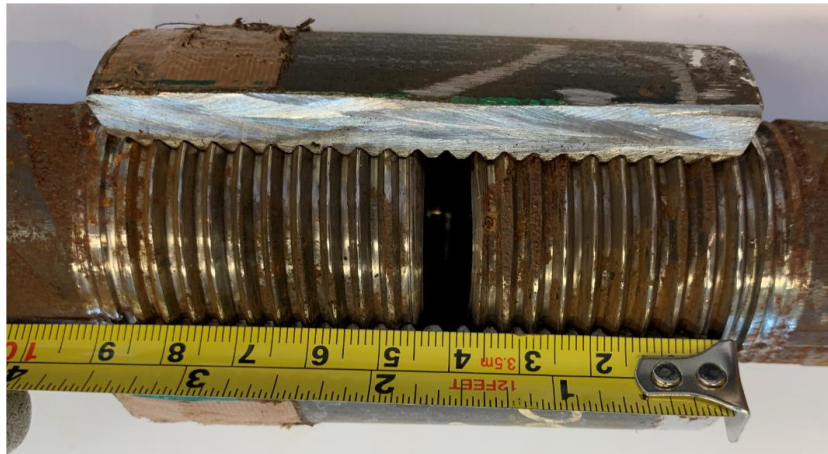
39. By accepting a thread engagement length of 37mm and exposure of two threads – which will not result in a “butt to butt” connection (see below) – the Government must necessarily accept that “butt to butt” connection is not required for structural safety purposes. This is so, as a matter of simple arithmetic, and is confirmed by photographic evidence of what goes inside a coupler:-

Slide 15 of Mr Southward’s presentation which shows two rebar with 44mm threads, with one fully engaged and two threads exposed on the other

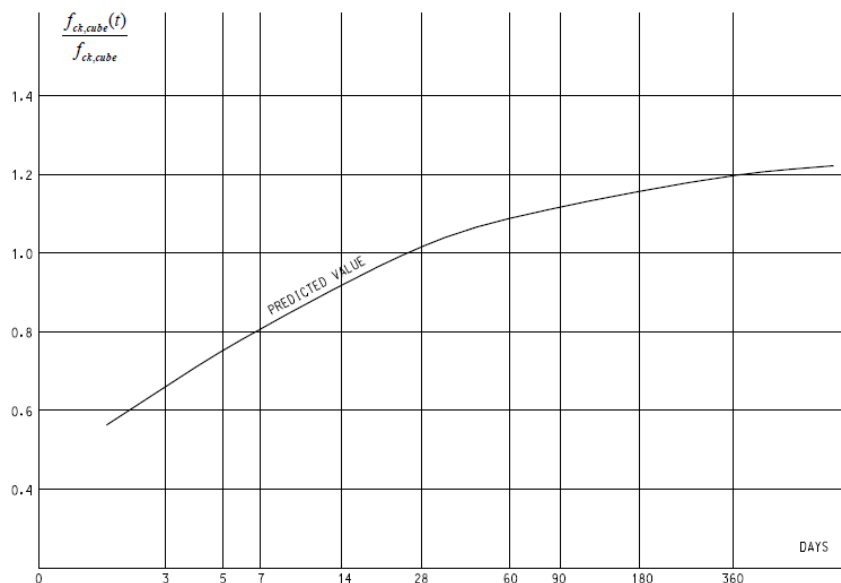
65. Atkins have assessed the shear using the concrete strength originally specified in the design. This ignored the fact that the 28-day cube concrete strength is proved by many tests to be considerably higher than the 28-day strength assumed by Atkins and that such strength would have increased over time (see diagram below).⁷⁰ Thus the shear strength of the slabs was underestimated by Atkins.

66. Where relevant, partial utilisation of the shear links should have been considered by Atkins.
