EXPERT REPORT

PROFESSOR DON McQUILLAN

Expert Witness appointed by the Commission of Inquiry
into the Diaphragm Wall and Platform Slab Construction Works
at the Hung Hom Station Extension under the Shatin to Central
Link Project

6 January 2019

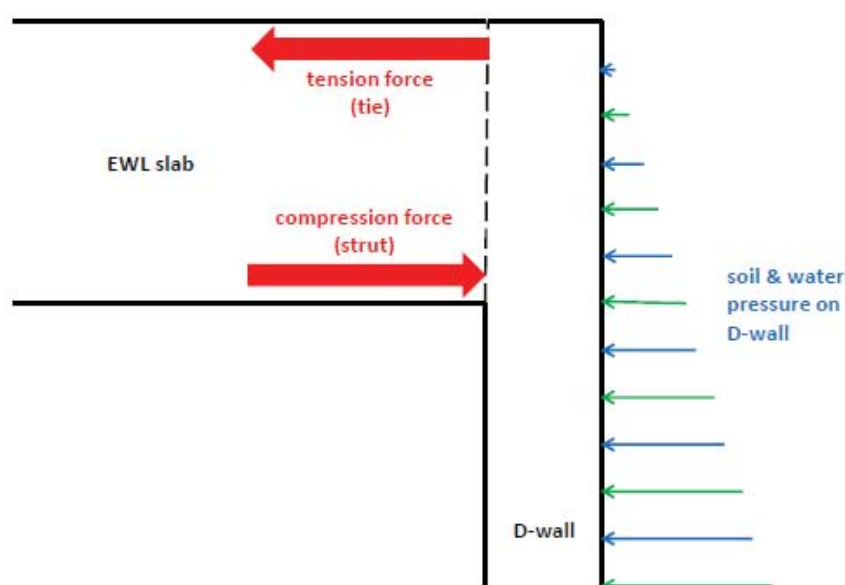
30. The diagram illustrating this concept in **Appendix II-5** is copied below to highlight the very important point that, at the interface between the EWL slab and the D-wall, the bottom of the slab is always in compression with the joint trying to close, whereas the top is always in tension trying to open.

To prevent interface opening top rebar is in tension (tie) with bottom rebar in compression (strut)

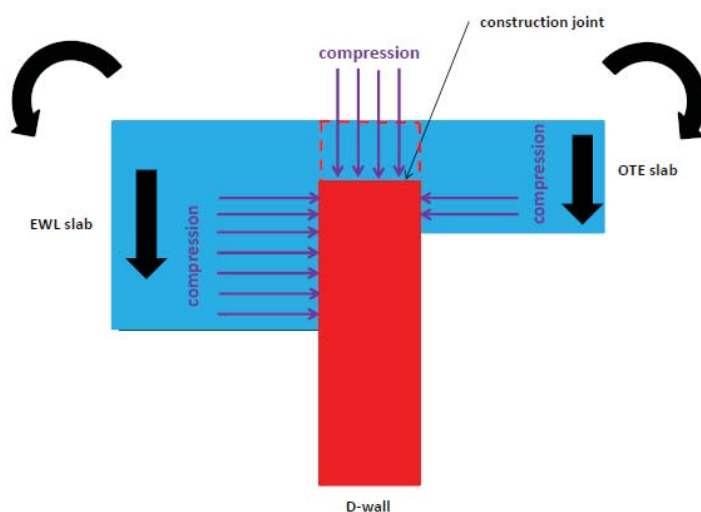
Schematic of amended EWL slab to east D-wall to OTE connection

100. The internal stresses at the top of wall construction joint are all of a compressive nature. The diagram illustrates why no tension or shear can occur at the interface. Any tendency for a shear force to develop across the interface would be resisted by the “clamping” action of the EWL and OTE slabs which bear against the D-wall.
