EXPERT REPORT

PROFESSOR DON McQUILLAN

Expert Witness appointed by the Commission of Inquiry
into the Diaphragm Wall and Platform Slab Construction Works
at the Hung Hom Station Extension under the Shatin to Central
Link Project

6 January 2019

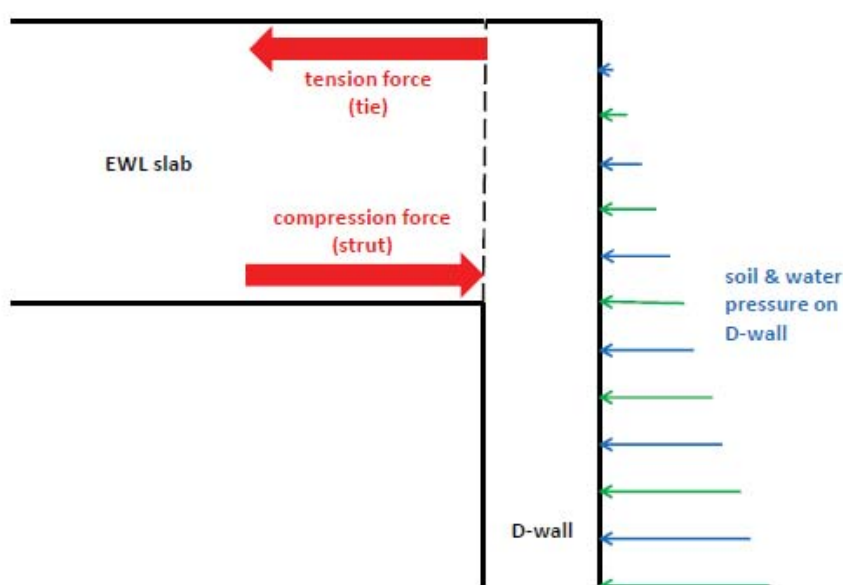
30. The diagram illustrating this concept in **Appendix II-5** is copied below to highlight the very important point that, at the interface between the EWL slab and the D-wall, the bottom of the slab is always in compression with the joint trying to close, whereas the top is always in tension trying to open.

To prevent interface opening top rebar is in tension (tie) with bottom rebar in compression (strut)

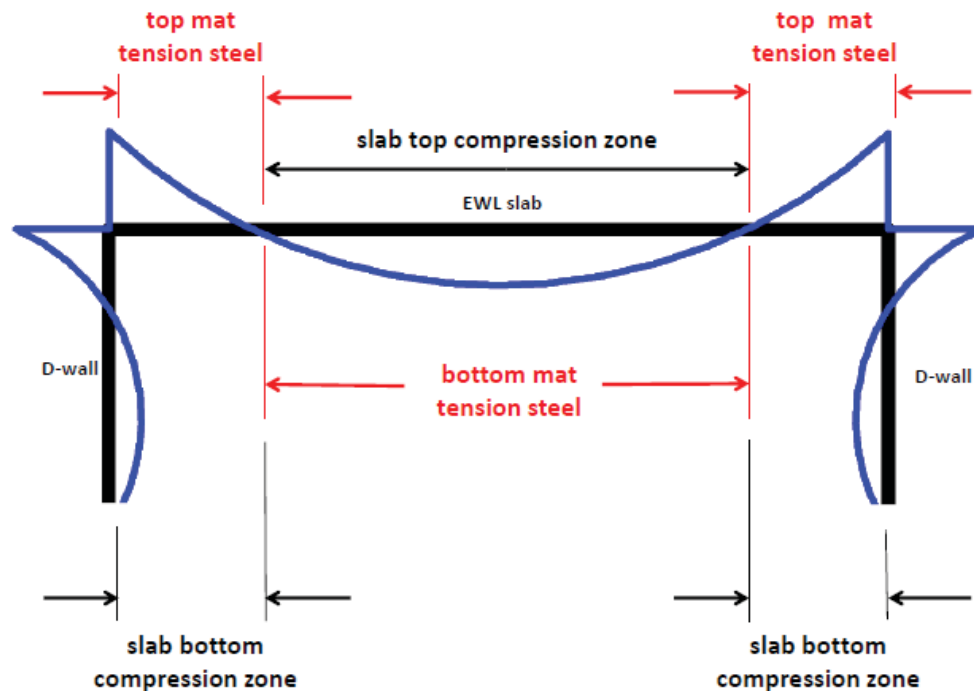
4. The bottom of the EWL slab at each D-wall is always in compression.
5. The flexural strength of the EWL slab is provided by the bottom mat tension steel, which is at a maximum at mid-span and which tails off towards the D-walls, and the top mat tension steel at the east and west D-wall connection. This is illustrated by the Bending Moment diagram (“blue” line) contained in **Appendix II-7** which I have annotated further and copied below for ease of reference. The top middle zone of the EWL slab is in compression, as are the bottom side zones adjacent to the east and west D-walls. Refer also again to the diagram in **Appendix II-5** which is copied at paragraph 30.

6. Shear resistance across the EWL slab to east D-wall interface is provided by the top tensile steel with a small contribution from the non-reinforced shear key.

7. Structural utilization throughout is relatively low meaning that there is adequate reserve capacity in the EWL slab and its east D-wall connections.

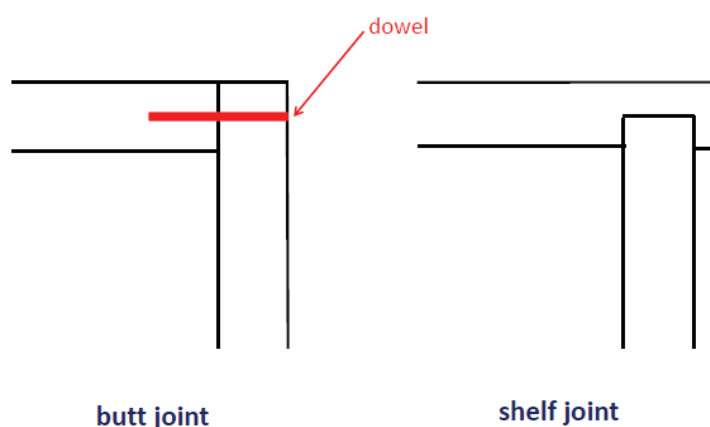
98. In my opinion the amended detail, as represented by the “first change” and as subsequently developed to represent the “second change”, is superior to the original fully coupled joint from both a structural and buildability perspective. More steel is provided across the top of the D-wall than originally intended. By way of analogy the two diagrams below show two different types of joint encountered when assembling e.g. IKEA flat-pack furniture.

99. Intuitively, and from experience, the shelf joint is superior to the butt joint in terms of its ease of construction and rigidity. The original design is analogous to the butt joint whereas the amended detail is analogous to the shelf joint. The schematic diagram below of the amended connection detail illustrates how the trimmed-down D-wall is encapsulated and “clamped” by the EWL slab bending away in one direction, the OTE bending away in the opposite direction, and the self-weight of the integral “block” of reinforced concrete (coloured in blue) which bears down on the top-of-wall construction interface. The “block” is prevented from splitting above the D-wall by the embedded tension rebar. In my opinion the “clamping” action compensates for the lack of “U” bars in the top of the D-wall.

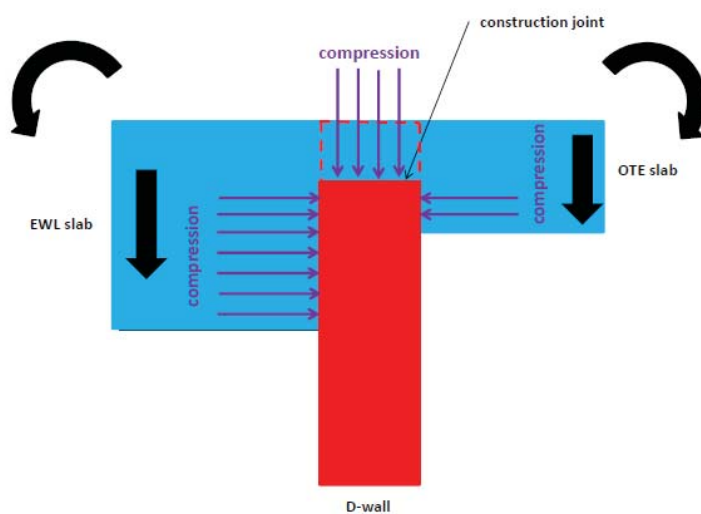
Schematic of amended EWL slab to east D-wall to OTE connection

100. The internal stresses at the top of wall construction joint are all of a compressive nature. The diagram illustrates why no tension or shear can occur at the interface. Any tendency for a shear force to develop across the interface would be resisted by the “clamping” action of the EWL and OTE slabs which bear against the D-wall.

101. Atkins ⁹⁵ [J6/4557-4567] subsequently produced design calculations for the first and second changes which demonstrate:
- For the first change the EWL slab-to-D-wall connection is so rigid that any rotation caused by slab deflection would create a horizontal crack in the D-wall just below the joint i.e.at the EWL slab soffit as shown in the diagram [J6/4557]. In this event the D-wall is more than adequately reinforced.
