# **MTRCL Shatin to Central Link Contract 1112 Hung Hom Station & Stabling Sidings**

**Change of Details at Eastern Diaphragm Walls and Slabs**

<b>Project:</b>	MTRCL Contract SCL 1112, Hong Kong
<b>Report Title:</b>	Change of Details At Eastern Diaphragm Walls and Slabs
<b>Document No:</b>	H118026-TG-SGN-GF-RP-CB-0001
<b>Revision:</b>	0
<b>Filename:</b>	H118026-TG-SGN-GF-RP-CB-0001.doc

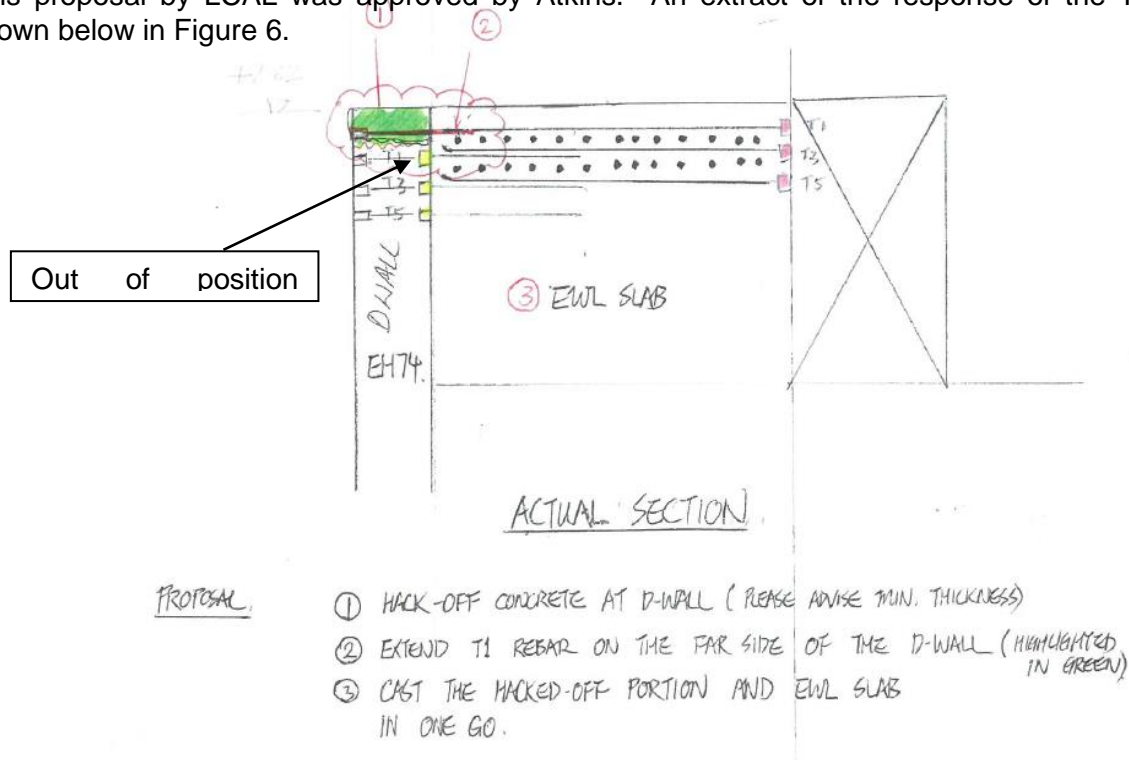
**Figure 6 – Extract from TQ 34 showing the proposed remedial**

This would have been caused by an out of tolerance installation of the reinforcement cage of this d-wall panel. As a result the levels of the reinforcement in the EWL slab would have dropped, reducing the strength of the concrete in this area of high stress, which would not be acceptable.

As a remedy it was proposed via TQ 34 to trim off the top portion of the d-wall so that bars from the EWL slab could be installed at the correct level. This involved removing the top layer of coupled bars and replacing with them continuous bars. Refer to figure 6 below.

This proposal by LCAL was approved by Atkins. An extract of the response of the TQ is shown below in Figure 6.

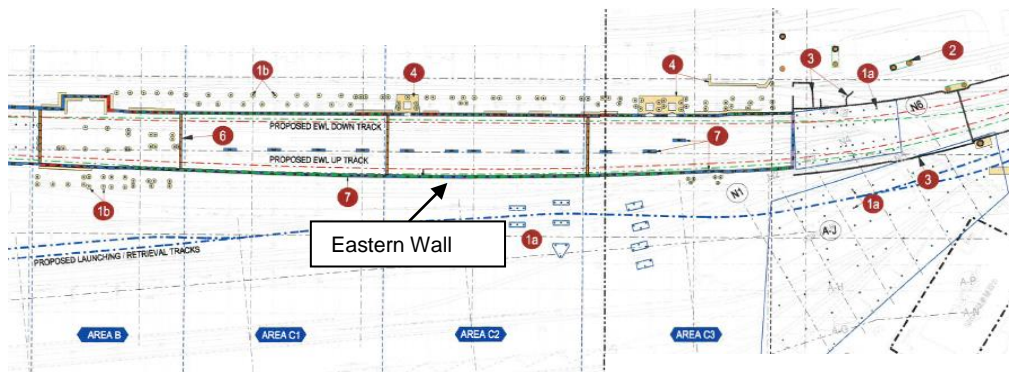
**Figure 7 – Areas affected by out of tolerance d-wall**

As a result of (i) the acceptance of the proposal in TQ 34, (ii) the response to TQ 33 and (iii) LCAL's proposal of the use of continuous reinforcement in the BD consultation document (TWD-004B3, as referred to 7.4.1 above), the method described in 7.4.5 below was developed and expanded to cover other sections of the eastern d-wall in Areas B and C1, C2 and C3.

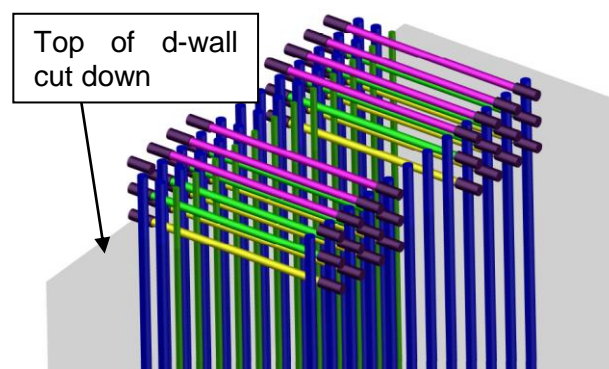
**Figure 8 – Removal of concrete at top of d-wall**

The top 420mm of concrete of the d-walls was removed, so exposing all the horizontal T40 reinforcement with the couplers at each end shown in the working drawings detail.

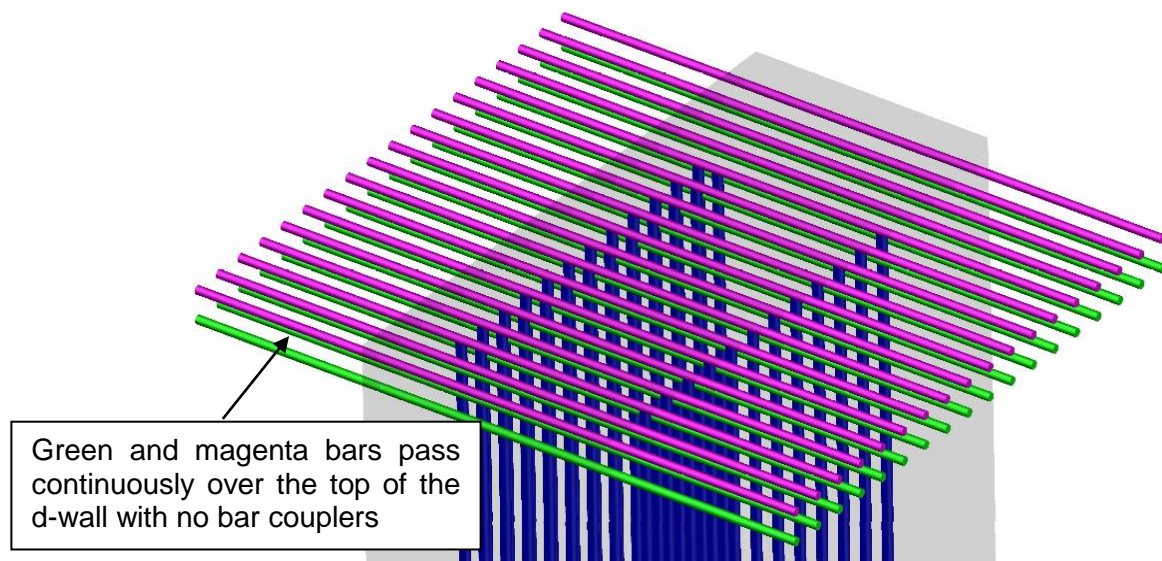
**Figure 9 – Revised Reinforcement Arrangement**

This approach allowed the contractor to remove the exposed bars and couplers and replace them with 2 layers of T40 bars at 150 spacing, the bars being continuous between the EWL slab, through the top of the d-wall and into the OTE slab without any couplers. Refer to Figure 9 below.

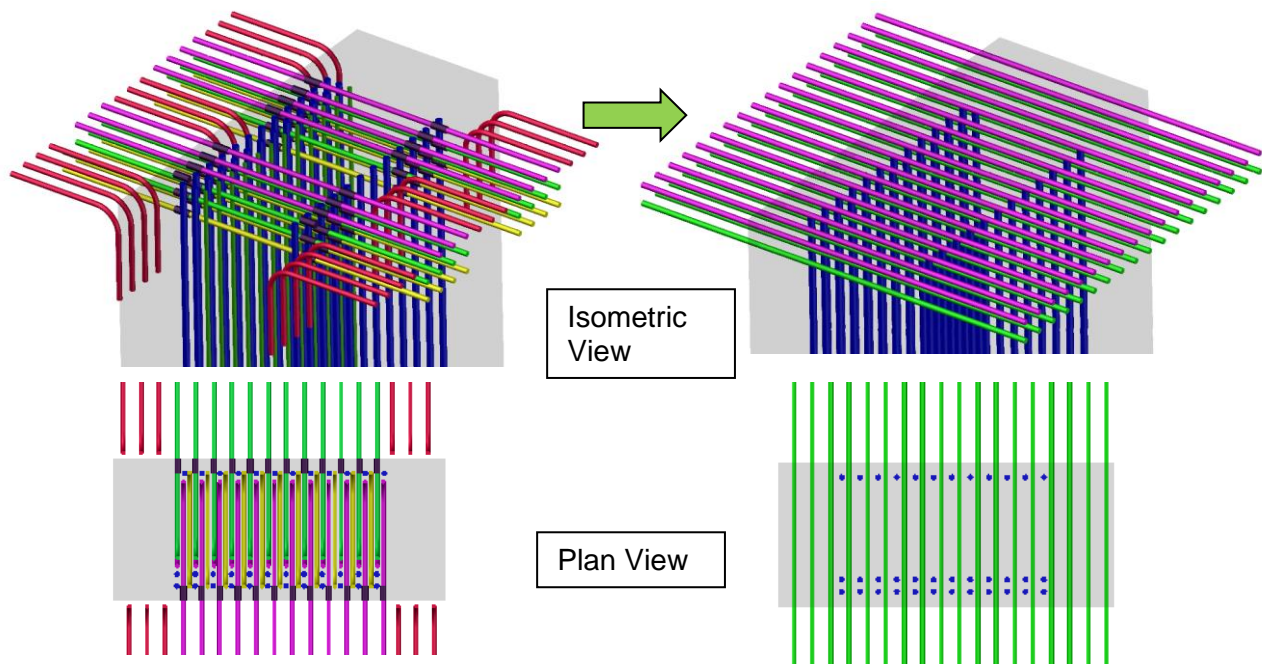
**Figure 10 – Increase in EWL Slab reinforcement**

The as-constructed detail increases the amount of reinforcement that connects the EWL slab to the d-wall, so the structure has an increased amount of strength and hence robustness and redundancy. This is because the amount of longitudinal reinforcement is increased. In Figure 10 below the red bars provide no structural strength to the EWL slab in this location as they are not connected into the d-wall and therefore do not contribute to the strength of the connection. Therefore the only bars that contribute are the magenta, green and yellow bars, 24 total per d-wall panel. In the as-constructed detail there are 36 bars of the same size (18 x 2) that contribute the strength of the connection. As a result, the bending strength of the EWL slab locally over the top of the d-wall has increased by 50%.

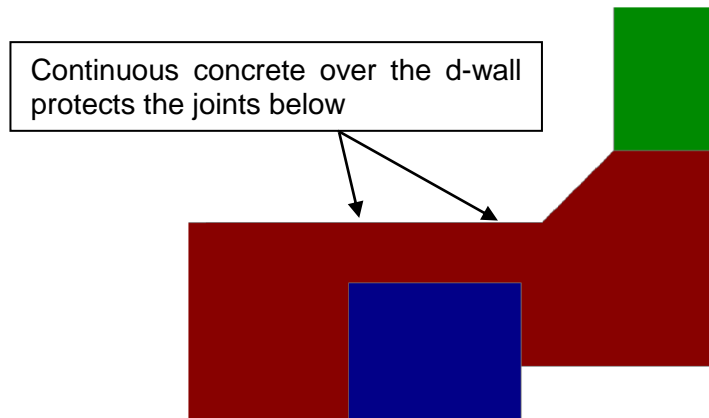
**Figure 12 – Improved Arrangement of Construction Joints in As Constructed Detail**

Thus, in the as-constructed detail, the vertical construction joints between the diaphragm wall and the slabs were eliminated in the area of the main tension steel by the use of a continuous concrete pour between the EWL, over the wall and into the OTE slab.

So by elimination of this joint in the top surface of the slab / d-wall concrete and in combination with the increase in the reinforcement, there will be an increase in the robustness and durability of the structure.

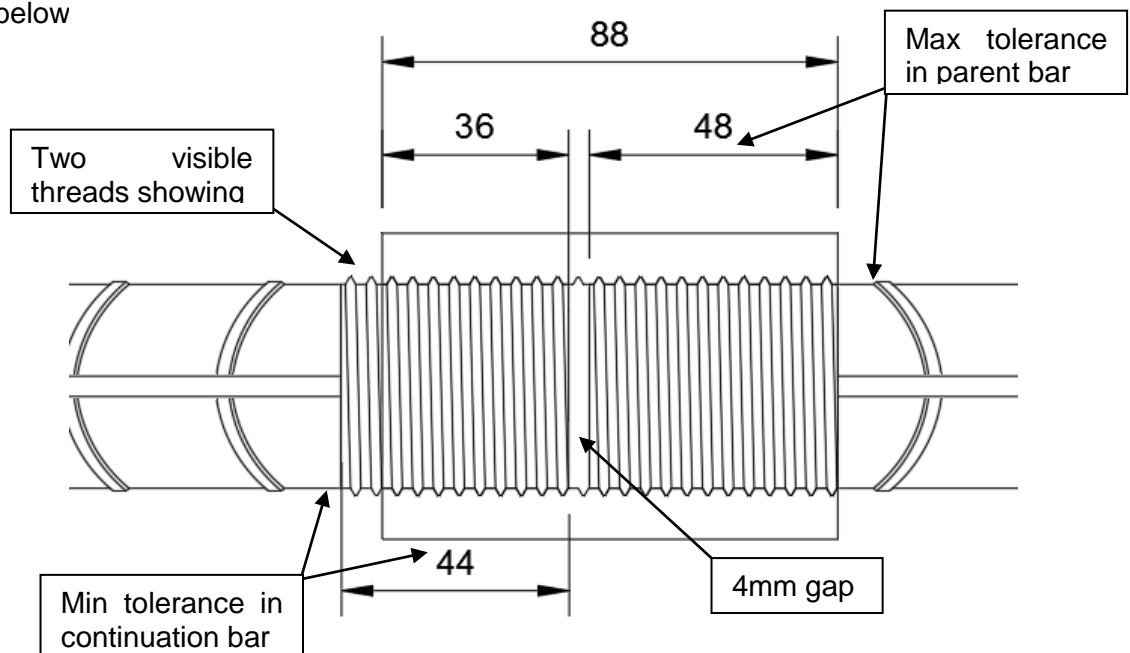
**Figure 16 – Minimum Embedment Length as a result of BOSA Tolerances**

As a consequence of these tolerances that BOSA have built into their coupler system, it would be possible to end up with an arrangement that has a 4mm gap between the ends of the bars inside the coupler and the continuation bar having an embedment length of **36mm** as shown in Figure 16 below

Therefore, 36mm is, by default and by direct consequence of the in-built tolerances in BOSA's system, the permitted minimum embedment length of T40 bar into a coupler.

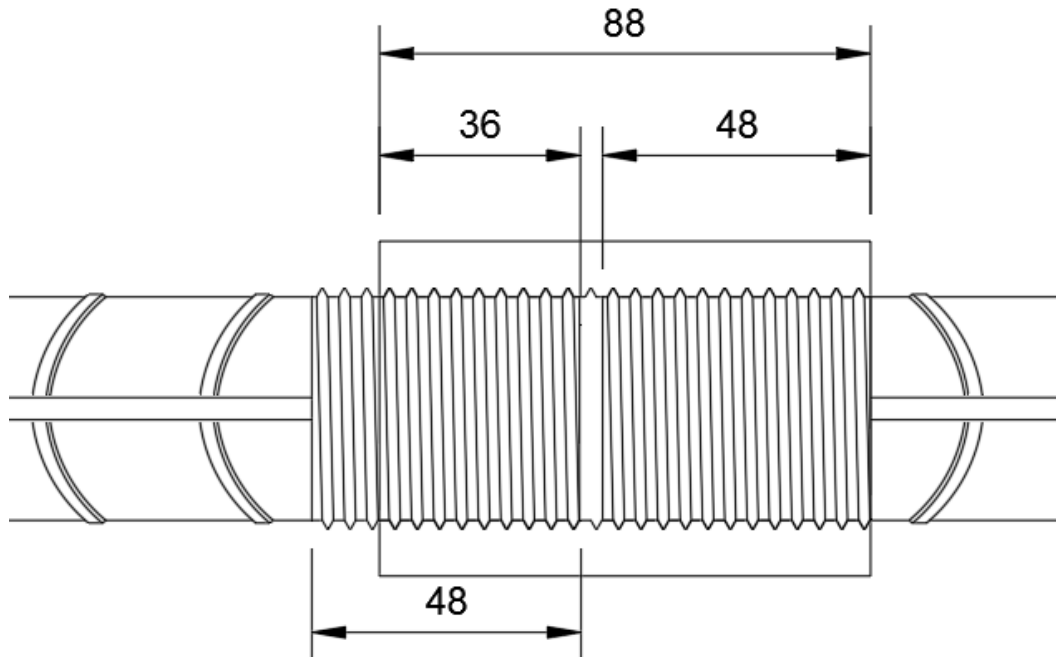
**Figure 17 – Case of three threads exposed**

Because 36mm is the minimum embedment length it would be possible to see three threads exposed and for this to not be a cause for alarm or for a sign of non-conformance. This would happen if the continuation bar had been threaded with the additional 4mm tolerance to give the maximum threaded length of 48mm, as shown in figure 17 below:

Thus, during the opening up process, if couplers are seen with three threads exposed in the continuing bar it cannot be said by visual inspection alone that this coupled connection does not meet the BOSA specification.
