**COMMISSION OF INQUIRY INTO THE DIAPHRAGM WALL AND PLATFORM
SLAB CONSTRUCTION WORKS AT THE HUNG HOM STATION EXTENSION
UNDER THE SHATIN TO CENTRAL LINK PROJECT**

**REPLY WITNESS STATEMENT OF WONG CHI CHIU
FOR
MTR CORPORATION LIMITED**

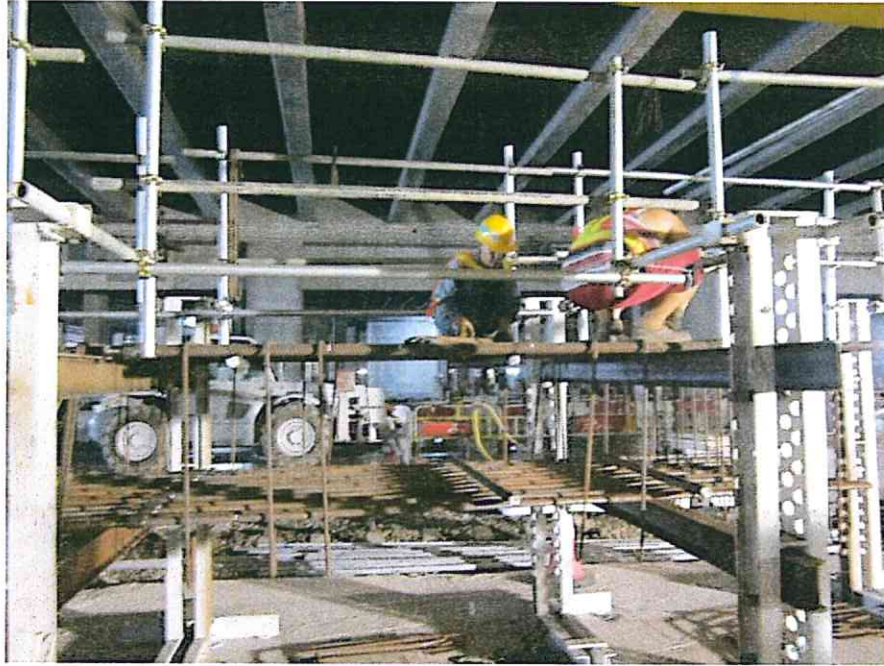
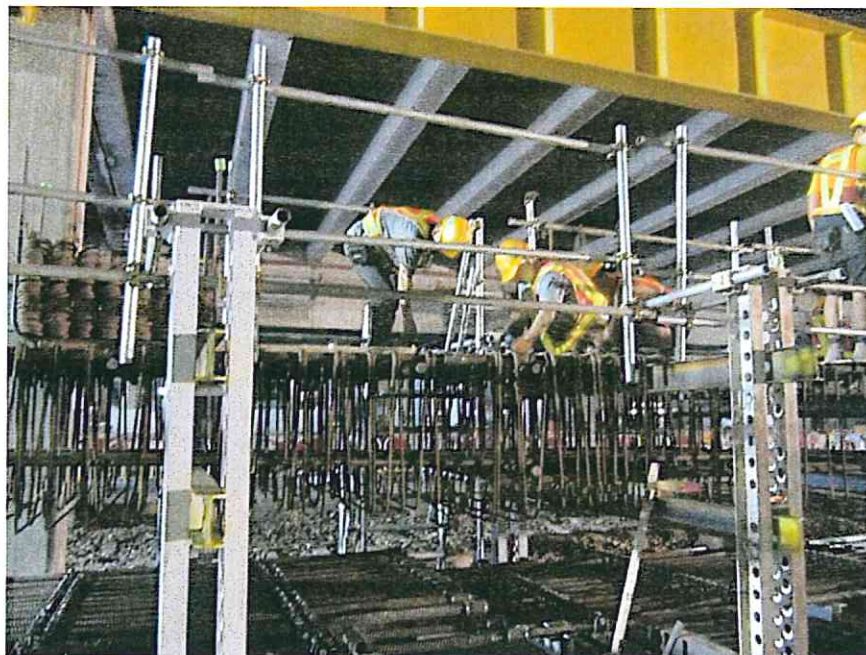
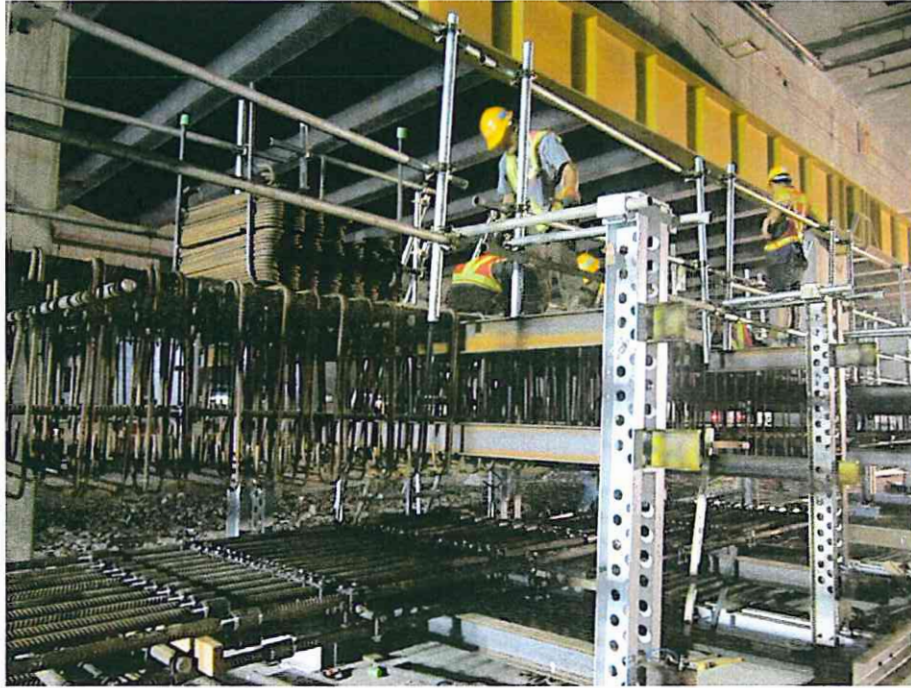
horizontally on the L-frame workbench. As Mr Gillard has rightly pointed out, this trial made use of all the pre-fabricated rebar cages for the first panel of the diaphragm wall, namely panel EM 98 in Area C3. I refer to **Images 5 to 7** below which show the trial in progress and appear to correspond to the footage in the video published by HK01.

Image 5: fixing of steel cages for panel EM 98 during July 2013 trial

Image 6: fixing of steel cages for panel EM 98 during July 2013 trial

Image 7: fixing of steel cages for panel EM 98 during July 2013 trial

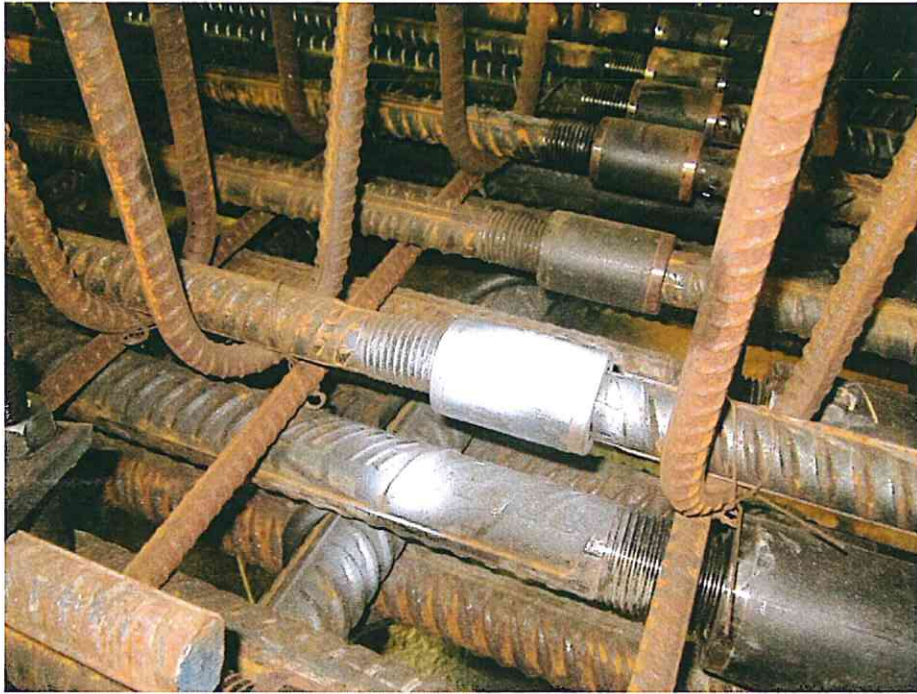
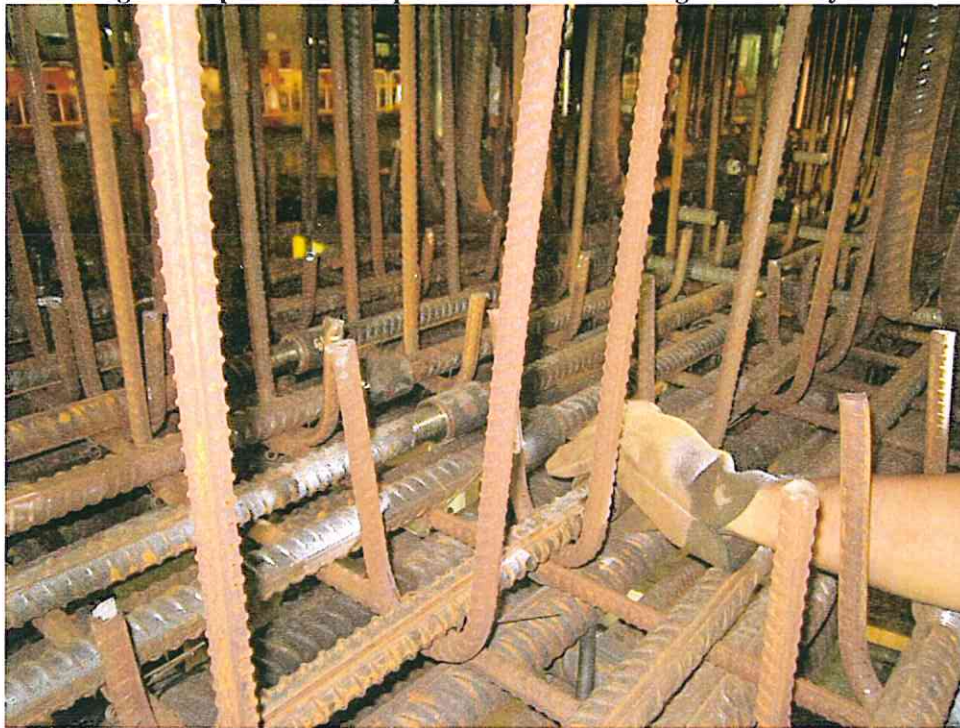
12. As shown in the images above, during this trial, all the pre-fabricated cages were first connected horizontally on the L-frame workbench, and at this stage, the coupler splicing assemblies were inspected by myself and/or the other IOWs/AIOWs/Works Supervisors as shown in **Images 8 to 9** below. I recall there were some practical difficulties in aligning and connecting the couplers/rebars with the cages lying horizontally, and for this reason this construction method was not adopted in subsequent panels.

Image 8: inspection of coupler connections during trial in July 2013

Image 9: inspection of coupler connections during trial in July 2013

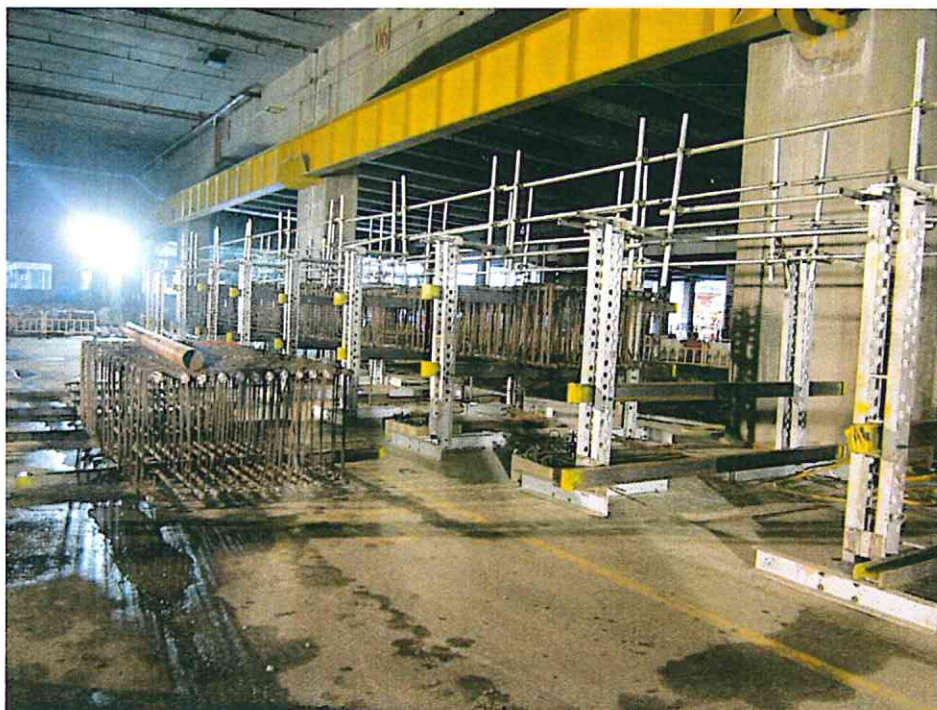
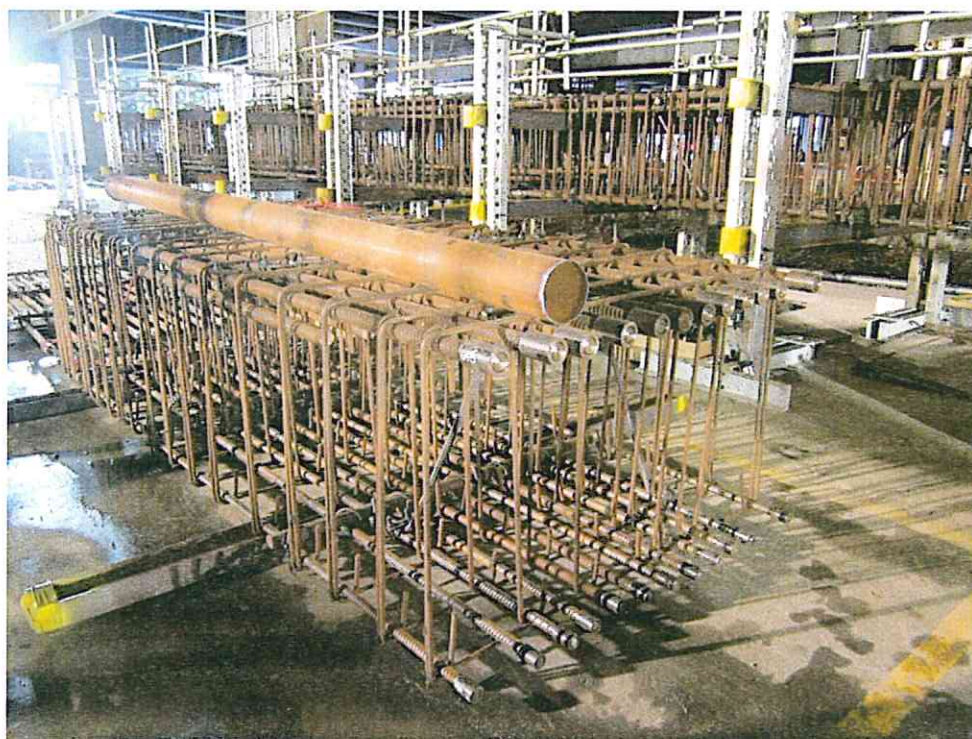
13. The connected cages were subsequently disconnected and transported to the panel location to be re-connected and lowered into the trench, and as far as the video published by HK01 seeks to suggest that the cages were not properly connected in the panel, that is simply incorrect. I refer to **Images 10 to 11** below which show the disconnection of the horizontally connected cages.

Image 10: disconnection of steel cages for panel EM 98 as part of July 2013 trial

Image 11: disconnection of steel cages for panel EM 98 as part of July 2013 trial

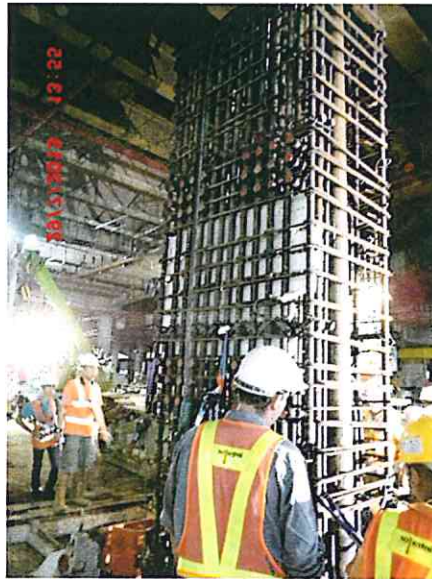
Image 12: rebar cages being installed at location of panel EM 98

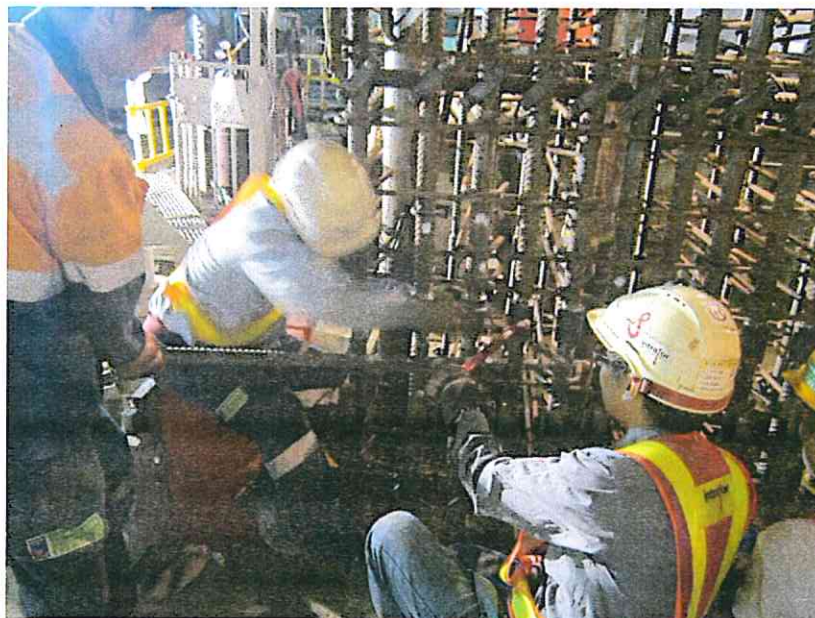
Image 13: splicing works at location of panel EM 98

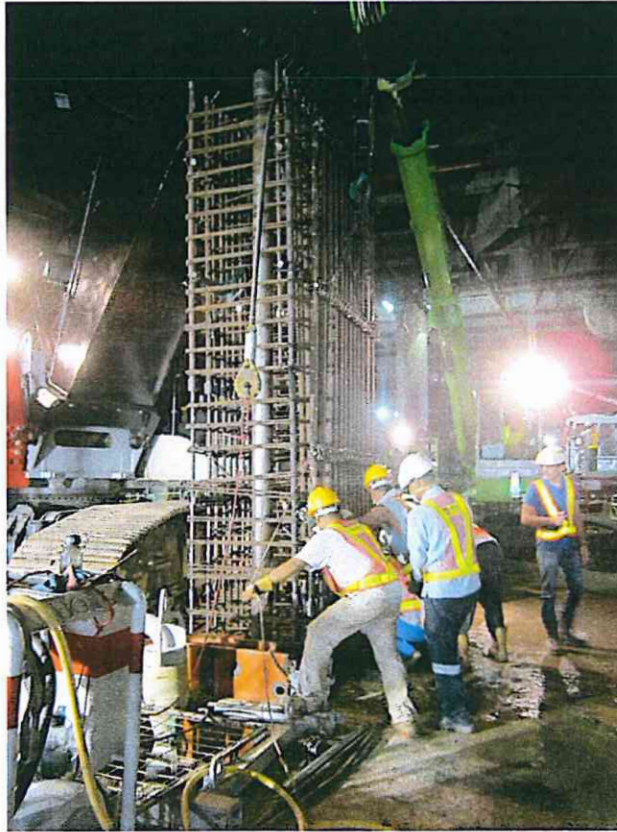
Image 14: splicing works at location of panel EM 98

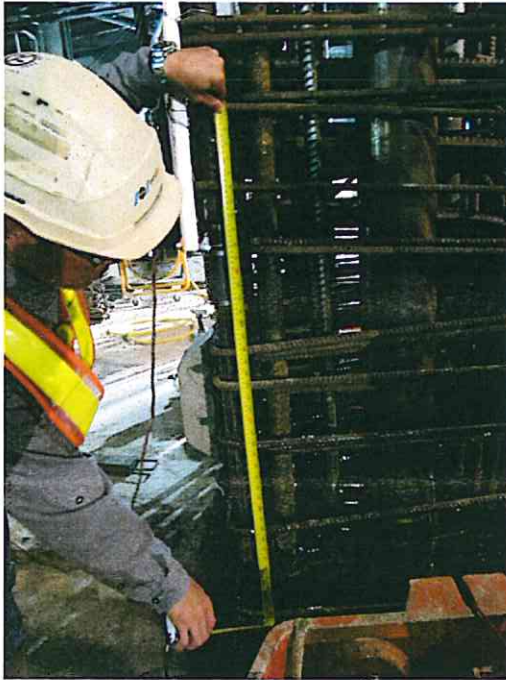
Image 15: splicing of 2nd and 3rd steel cages

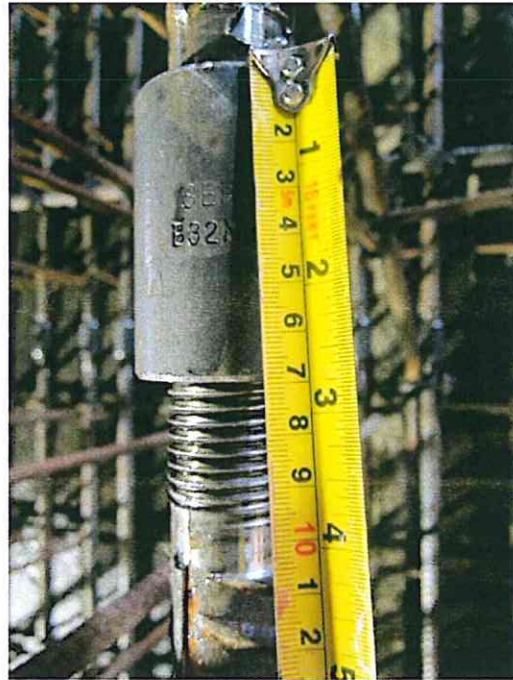
Image 16: measurement of exposed thread

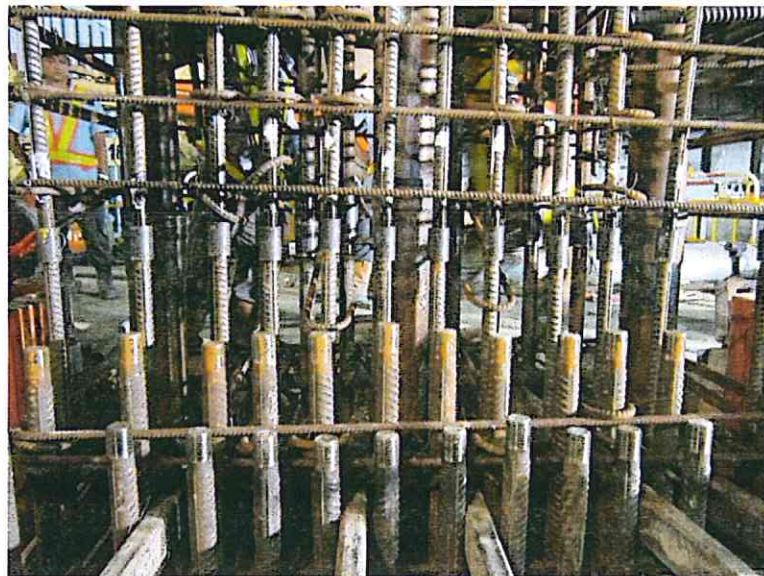
Image 17: completed splicing assemblies of innermost layer for 2nd and 3rd steel cages
(Note that couplers were properly screwed down but did not have to be flush with each other)

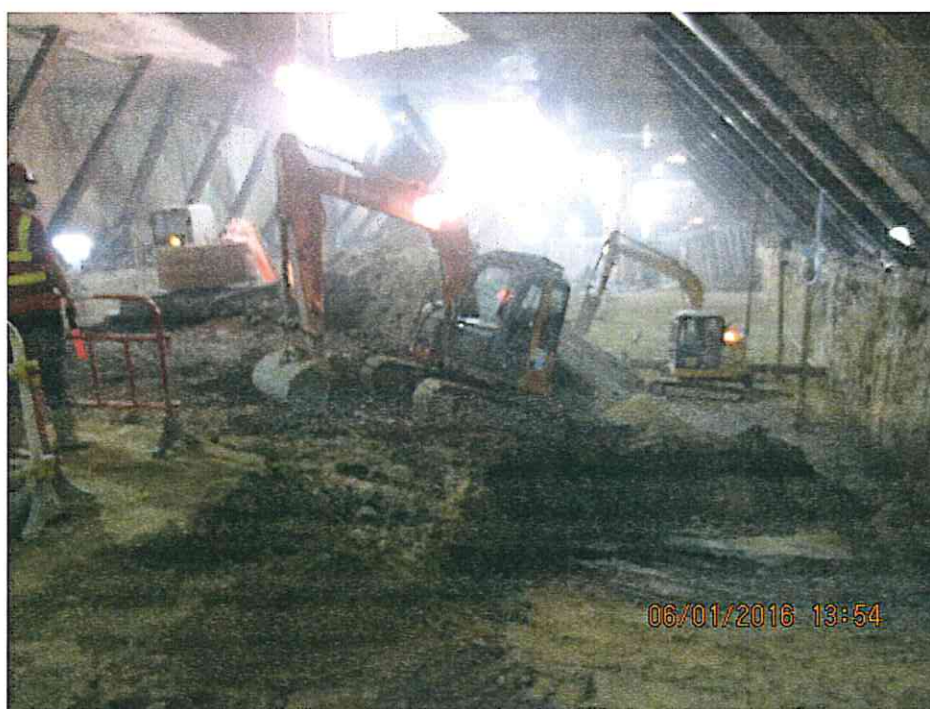
Image 18: site conditions during excavation down to NSL level in Area C2-3

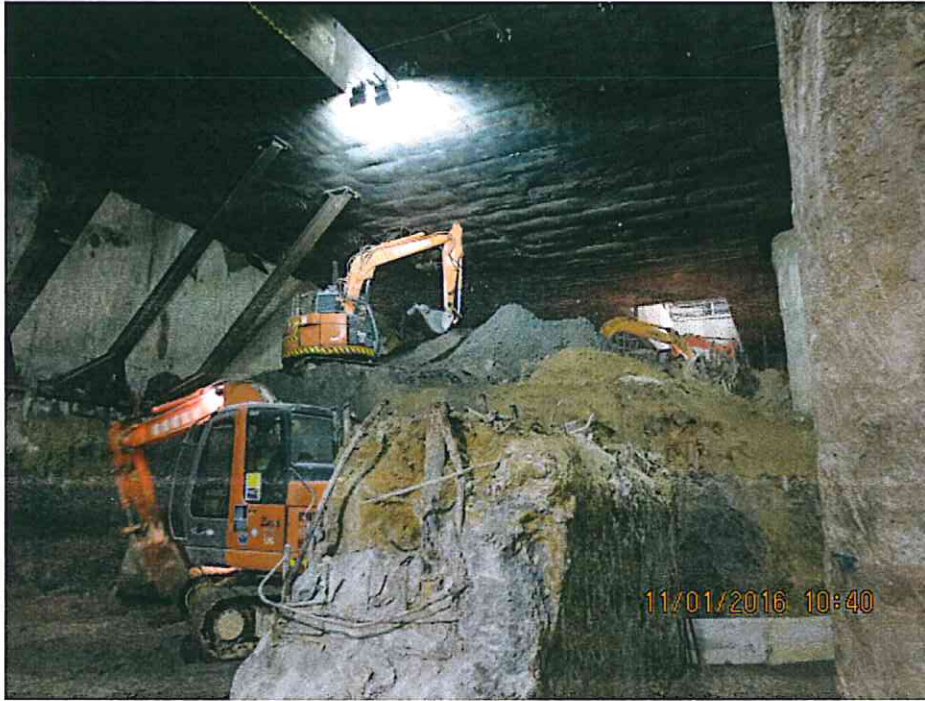
Image 19: site conditions during excavation down to NSL level in Area C2-4

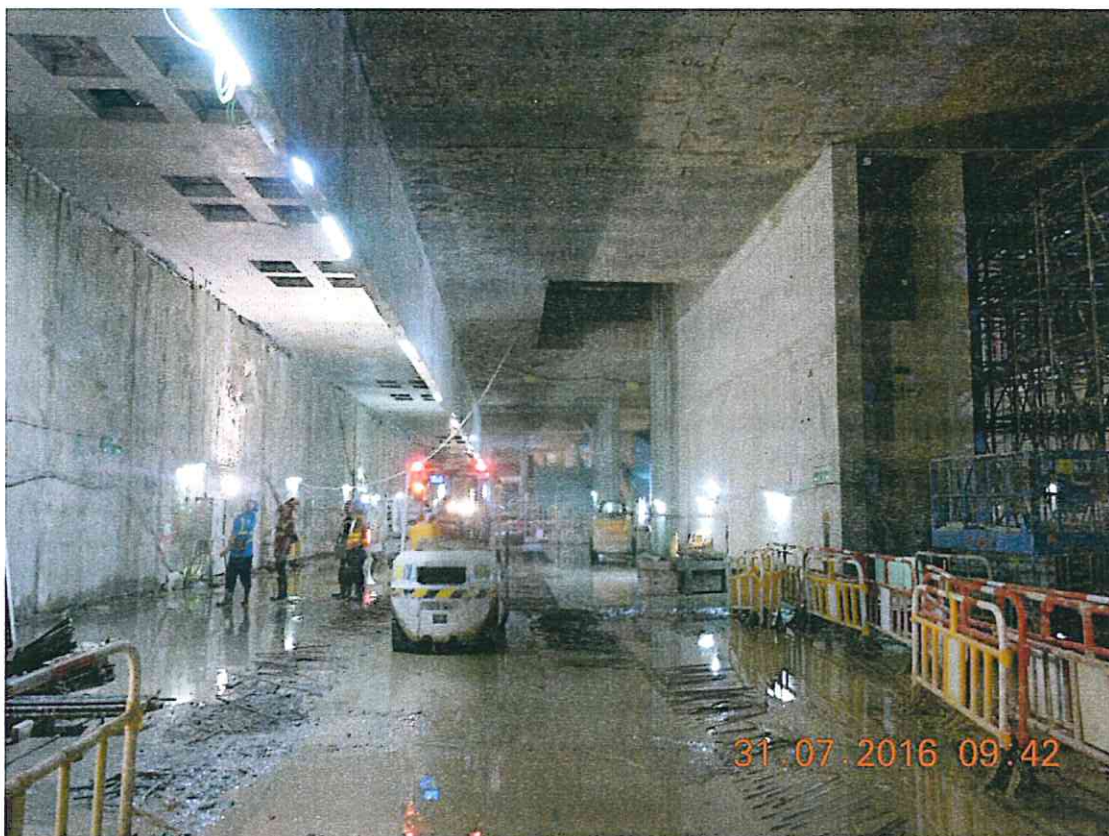
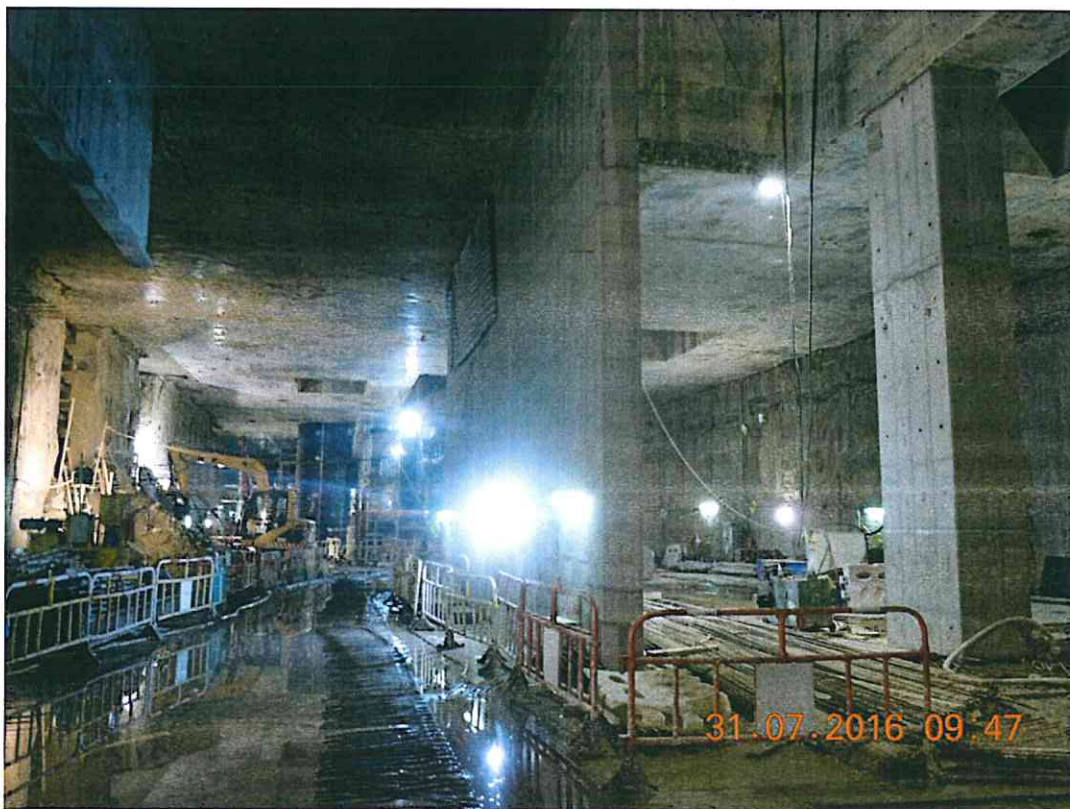
24. I should add that for the locations where no honeycombing was observed during the post-pour snagging process, there were no visible signs of defects or abnormalities in the concrete surface of the soffit which would be apparent on a visual inspection from a distance, as can be seen in **Images 20 to 21** below which were taken in Area C.

Image 20: general condition of EWL slab soffit after concrete was poured

Image 21: general condition of EWL slab soffit after concrete was poured
