**COMMISSION OF INQUIRY INTO THE DIAPHRAGM WALL AND PLATFORM  
SLAB CONSTRUCTION WORKS AT THE HUNG HOM STATION EXTENSION  
UNDER THE SHATIN TO CENTRAL LINK PROJECT**

**WITNESS STATEMENT OF WONG CHI CHIU  
FOR  
MTR CORPORATION LIMITED**

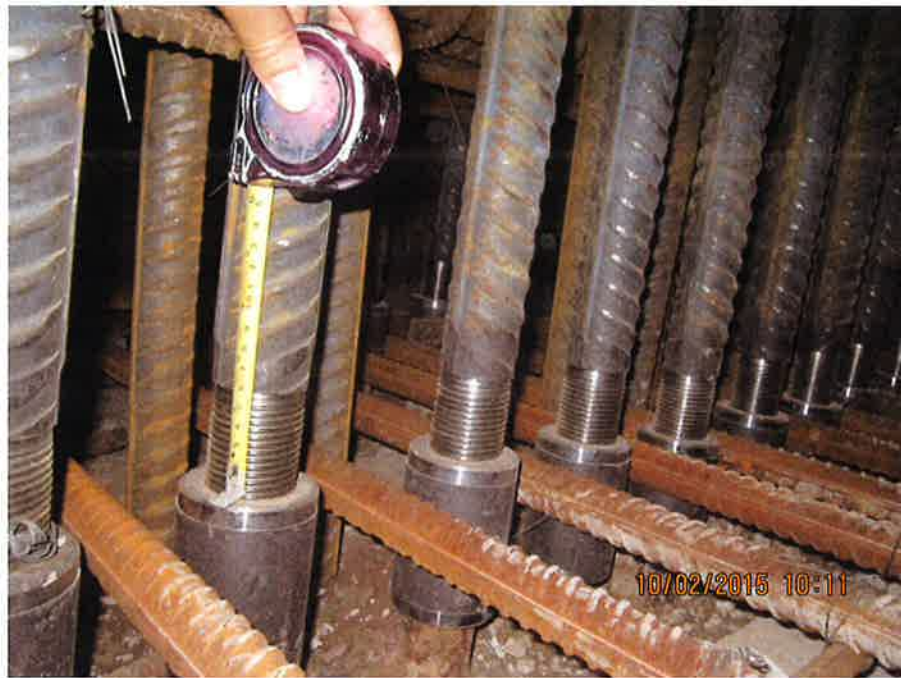
29. For the steel rebar cages of the diaphragm walls which were connected using Type B connections, I would normally check the splicing assemblies by measuring the exposed Type B threading, which should not be more than half of the full length of the threaded end as specified in the QSP (see **image 3** below). Further, once a new layer of rebar

**Image 3 – measurement of exposed threading of Type B rebars in diaphragm wall in Area C2-3.**

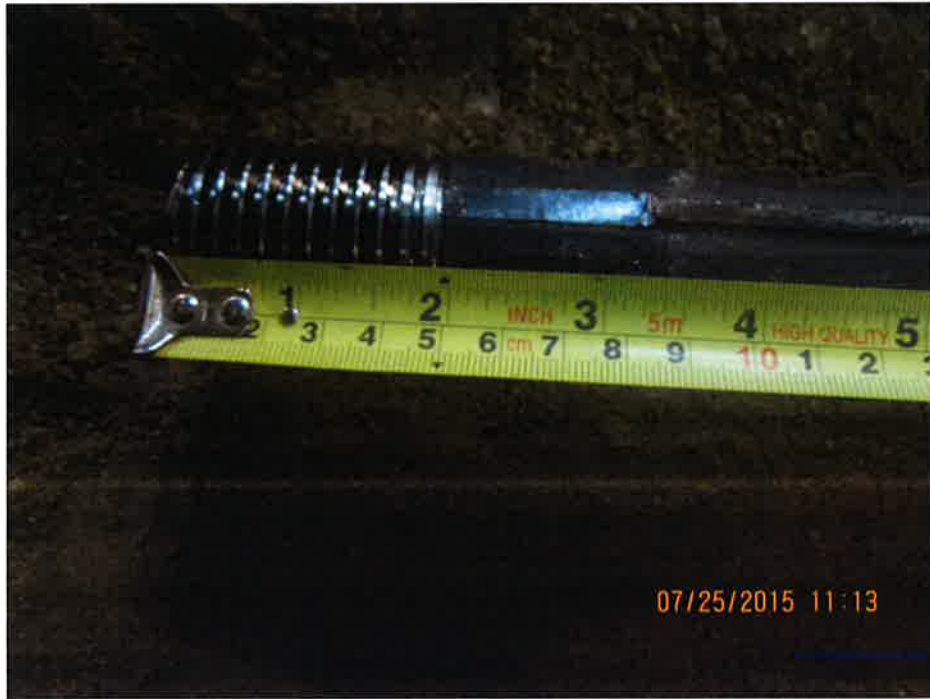
30. When the IOWs, AIOWs and I conducted site surveillance of the EWL slab works, we would pay attention to whether the Type A splicing assemblies were within the tolerance of not more than 1 to 1.5 full pitches of threading being exposed, as per the footnote in the template record sheet in Appendix B to the QSP. We did so by counting the crests (i.e. not the roots) of the threaded end. I should emphasise that there was no need to use a pipe wrench for the inspection, and no specific torque was required – this was clearly and expressly stated in the BOSA '*Coupler Installation Method*' document. A visual inspection (with the help of a tape measure to measure the length of the threaded end) was sufficient for an experienced inspector like myself (see **image 4 below**), and it would not be necessary to use any special equipment.

Image 4 – random checking of Type A threaded rebar (Y40) for 3m EWL slab in Area C1-1.

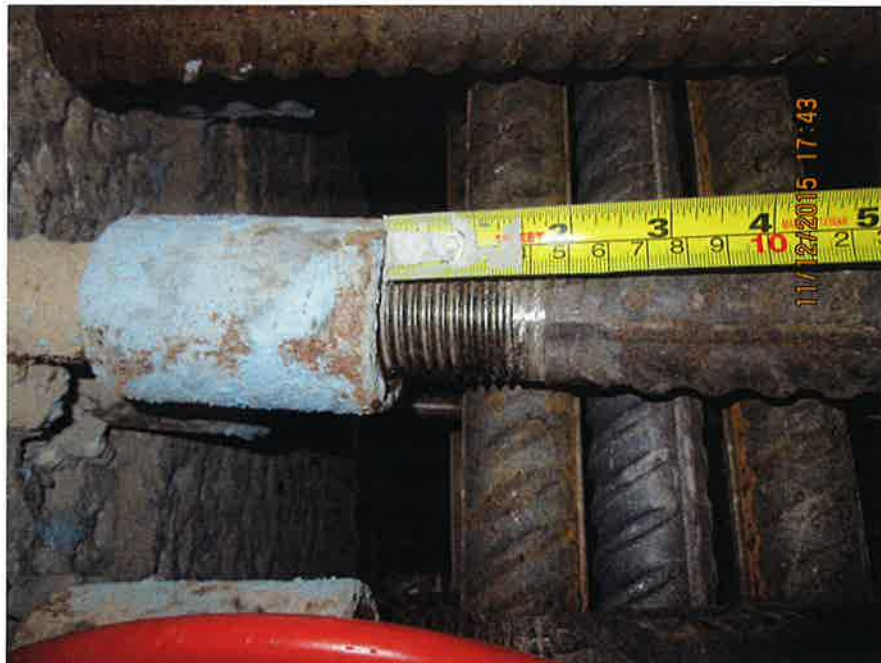
92. There were occasions when I saw the use of Type B rebars (with longer threaded ends) in conjunction with Type A connections at the joint between the EWL slab and the diaphragm wall in Area B. Upon reviewing the photographic records on MTRCL's project server, I recall occasions when we had to use a tape measure to check the length of the exposed threading, and then ask the workers to unscrew the rebar so that we could measure the full length of the threaded end (see **images 5 and 6 below**). Upon measurement, I was satisfied that it was a Type B threaded end which was properly spliced into a coupler at a Type A connection. To be clear, there was no cutting or shortening of the Type B threaded end.

**Image 5: measurement of exposed threaded end in Area B-1**

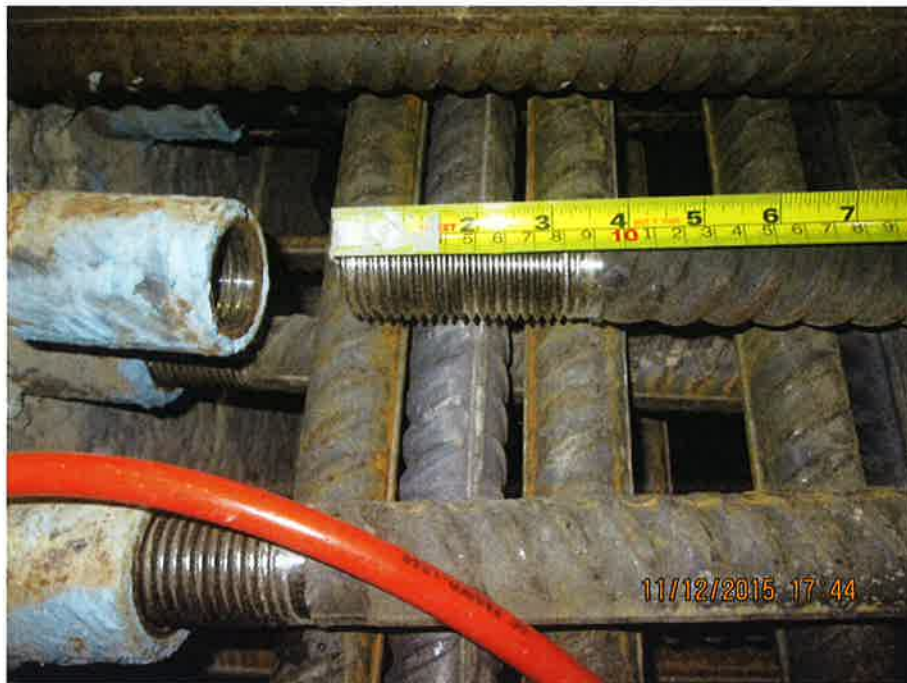
**Image 6: measurement of threaded end removed from coupler in Area B-1**
