COMMISSION OF INQUIRY INTO THE DIAPHRAGM WALL AND PLATFORM SLAB CONSTRUCTION WORKS AT THE HUNG HOM STATION EXTENSION UNDER THE SHATIN TO CENTRAL LINK PROJECT

WITNESS STATEMENT OF KWAN PAK HEI LOUIS FOR MTR CORPORATION LIMITED

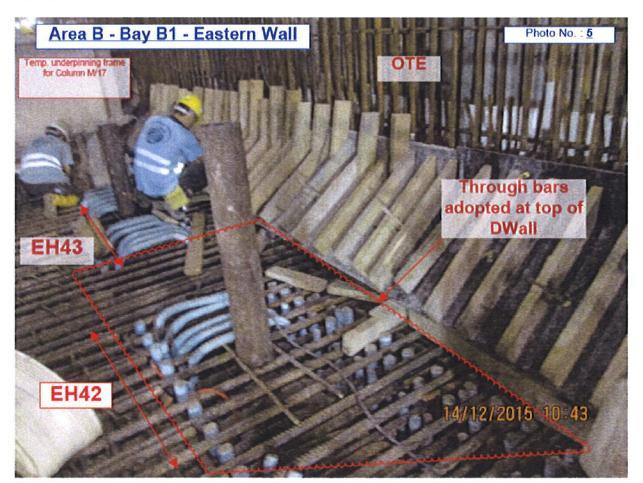
Image 3: site photo showing through-bars in the top layer of panel EH 42

56.1.2. I have checked that the number of rows/layers, spacing and diameter of the rebar connections observed on site were consistent with the working drawings, and this is confirmed by the relevant site photo (Image 3), which show two as-built rows of top layer through-bars connecting the EWL slab and the east diaphragm wall.⁶ The relevant drawings are contained in Appendix 1 hereto.

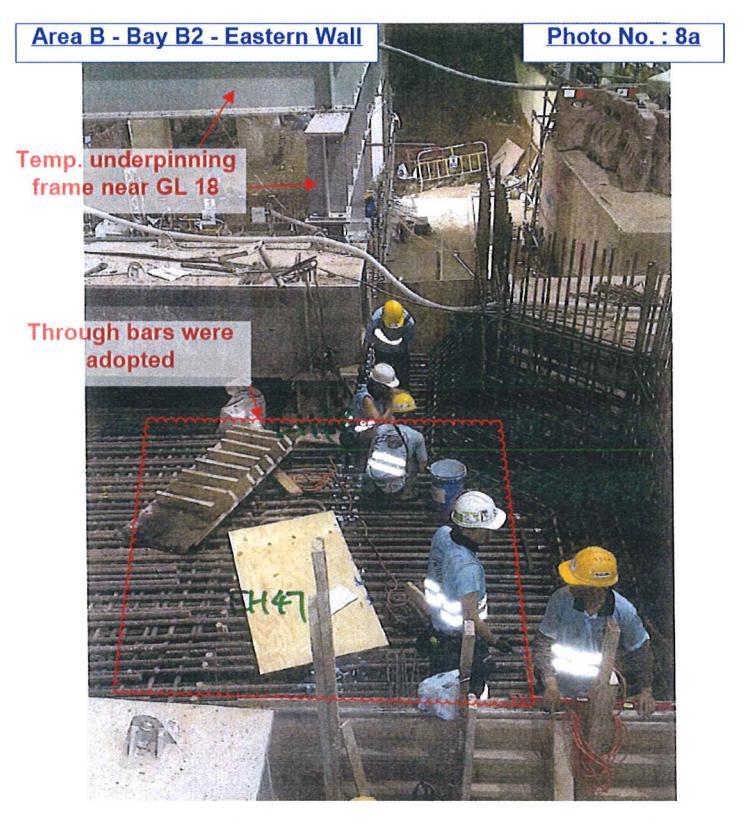
Image 6: site photo showing through-bars in the top layer of panel EH 47

56.2.2. I have again checked that the number of rows/layers, spacing and diameter of the rebar connections observed on site were consistent with the working drawings, and this is confirmed by the relevant site photo (**Image 6**), which show two as-built rows of top layer through-bars connecting the EWL slab and the east diaphragm wall.⁷ The relevant drawings are contained in **Appendix 2** hereto.

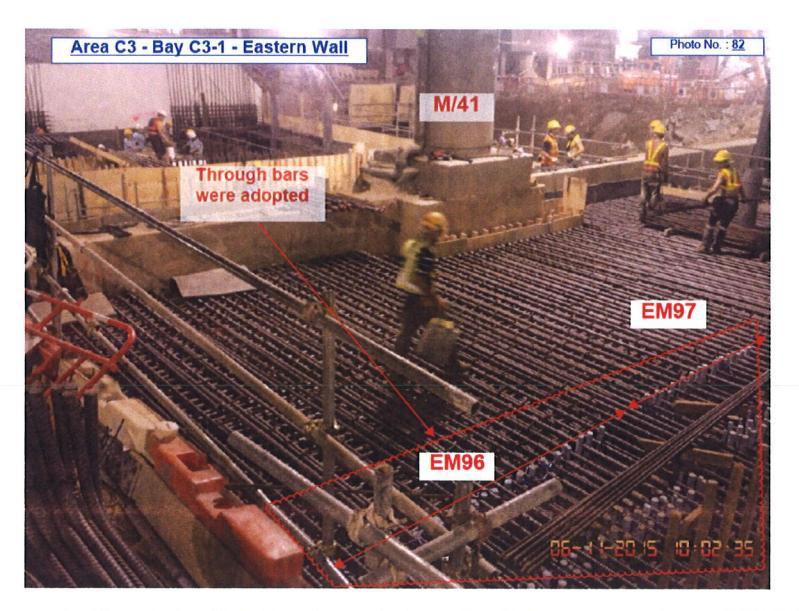
Image 9: site photo showing through-bars in the top layer of panel EM 96

56.5. Yet again, I have checked that the number of rows/layers, spacing and diameter of the rebar connections observed on site were consistent with the working drawings, and this is confirmed by the relevant site photo (Image 9), which show two as-built rows of top layer through-bars connecting the EWL slab and the east diaphragm wall.⁸ The relevant drawings are contained in Appendix 3 hereto.
