COMMISSION OF INQUIRY INTO THE DIAPHRAGM WALL AND PLATFORM SLAB CONSTRUCTION WORKS AT THE HUNG HOM STATION EXTENSION UNDER THE SHATIN TO CENTRAL LINK PROJECT

WITNESS STATEMENT OF CHAN KIT LAM FOR MTR CORPORATION LIMITED

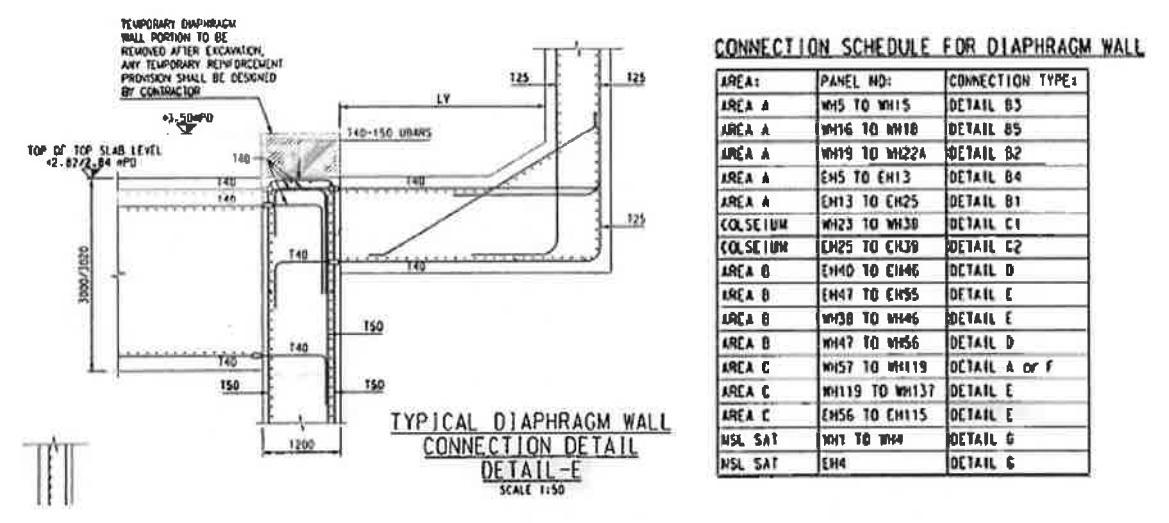
32. In addition to the Original Coupler Schedule, Atkins also produced working drawing no. 1112/W/HUH/ATK/C12/606 Rev. A dated 8 March 2013 entitled 'Permanent Diaphragm Wall RC for Panels Typical Details (Sheet 2 of 2)', which shows in Detail-E that the top layer reinforcement bars of panels EH47 to EH115 of the east diaphragm wall (*i.e.* Area C and part of Area B) would be connected with the reinforcement bars in the OTE slab using cast-in couplers on the earth side of that diaphragm wall: see the extracts from the drawing below. It is noteworthy that this is only an indicative 'typical' detail, and does not show the actual layers of reinforcement bars/couplers in each of the diaphragm wall panels. The number of layers is only shown in the Original Coupler Schedule.

33. It should be noted at this juncture that subsequently, in or around September 2015, this working drawing was revised to incorporate, among other things, a number of permutations to the above connection details at different locations/panels of the east diaphragm wall in (amongst other areas) Areas B and C. These were not changes in design, but permutations of the same design intent catering for the local conditions of each panel wall. It is common and necessary to include such permutations. By way of example, in drawing no. 1112/W/HUH/ATK/C12/606 Rev. C dated 21 September 2015

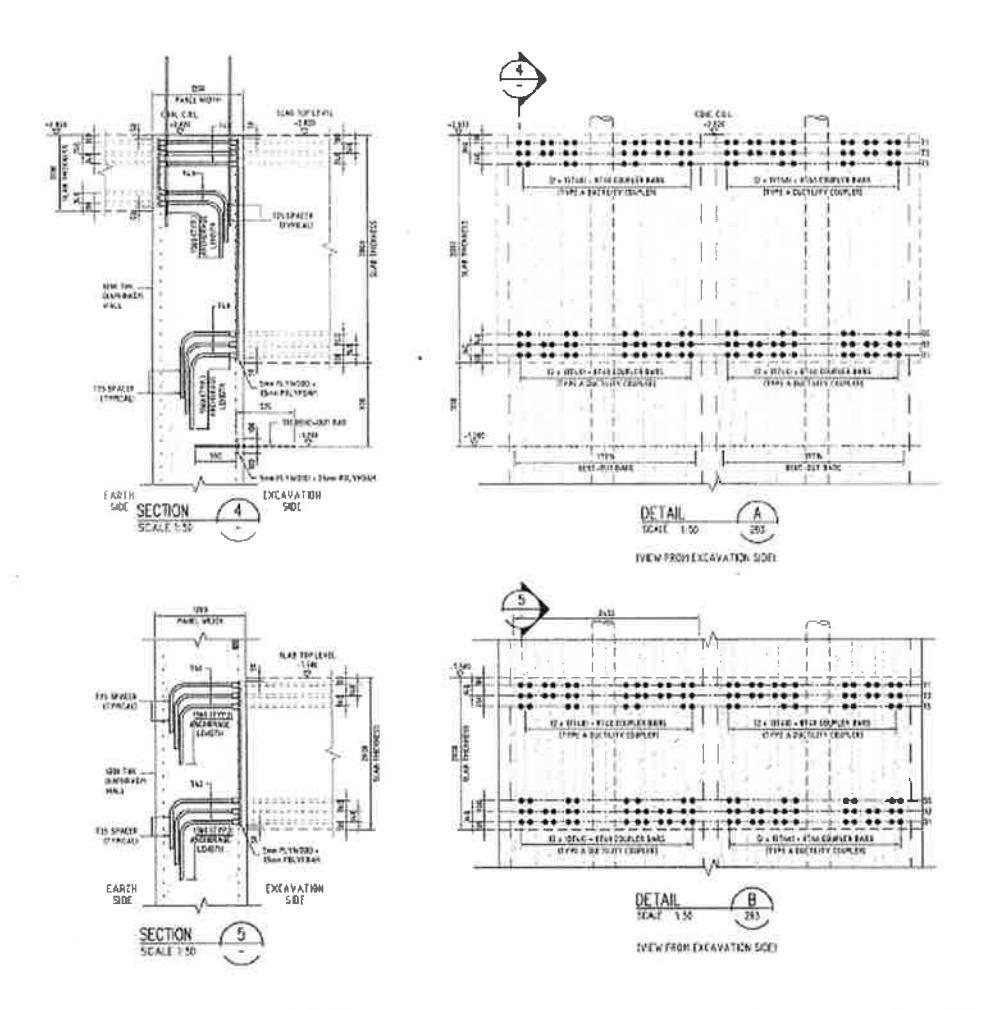
Shop drawing nos. 1112/C/HUH/LCA/C12/298 Rev. A2 dated 14 November 2013

- 36. This change was reflected in Intrafor's shop drawings as issued for construction see e.g. shop drawing nos. 1112/C/HUH/LCA/C12/298 Rev. A2 dated 14 November 2013 and A3 dated 16 January 2014, the revised details of which showed three layers of reinforcement bars and Type A ductility couplers at the top of panel EH 84 of the diaphragm wall in Area C (as shown in the extract below).
