COMMISSION OF INQUIRY INTO THE DIAPHRAGM WALL AND PLATFORM SLAB CONSTRUCTION WORKS AT THE HUNG HOM STATION EXTENSION UNDER THE SHATIN TO CENTRAL LINK PROJECT

WITNESS STATEMENT OF KWAN PAK HEI LOUIS FOR MTR CORPORATION LIMITED

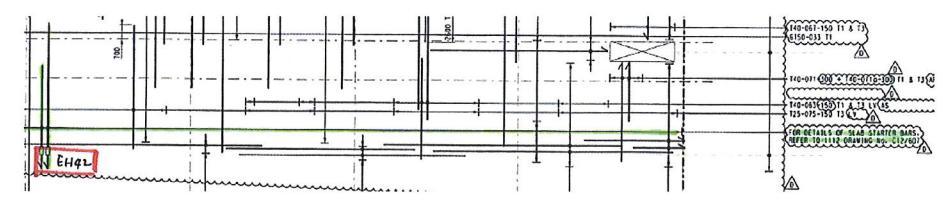
Image 1: drawing no. 179 Rev. D – annotation referring to drawing no. 607 Rev. B

56.1.1. Working drawing no. 1112/W/HUH/ATK/C12/179 Rev. D dated 21 September 2015 (Image 1) referred to the coupler schedule in working drawing no. 1112/W/HUH/ATK/C12/607 Rev. B dated 16 June 2015 (Image 2) (both of which were current at the time), which indicated two rows (T1 and T3) of T40 top layer rebars connecting the top of the east diaphragm wall to the EWL slab, with a spacing of 150 mm centre-to-centre.

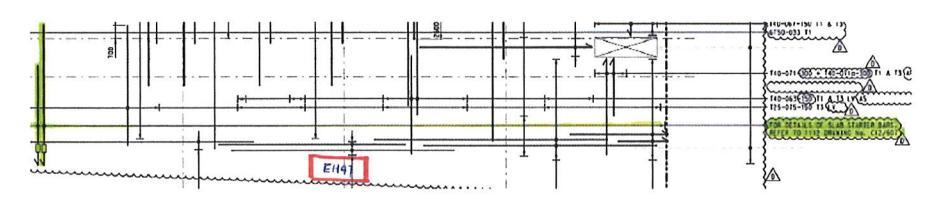
Image 4: drawing no. 179 Rev. D - annotation referring to drawing no. 607 Rev. B

56.2.1. Working drawing no. 1112/W/HUH/ATK/C12/179 Rev. D dated 21 September 2015 (Image 4) referred to the coupler schedule in working drawing no. 1112/W/HUH/ATK/C12/607 Rev. B dated 16 June 2015 (Image 5) (both of which were current at the time), which indicated two rows (T1 and T3) of top layer rebars connecting the top of the east diaphragm wall to the EWL slab, with a spacing of 150 mm centre-to-centre.

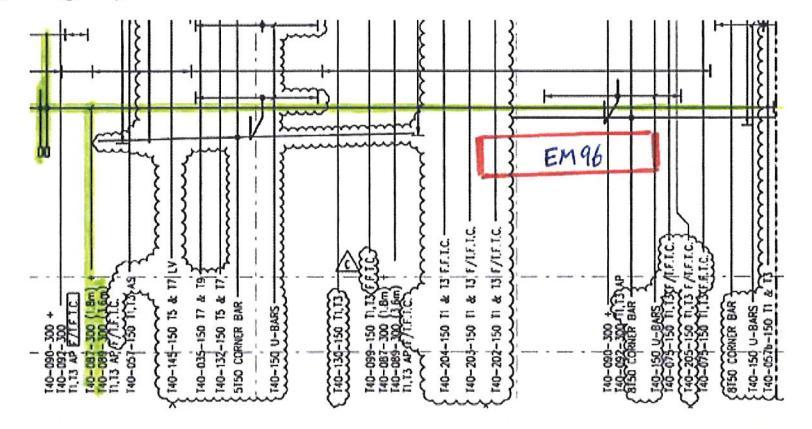
Image 7: drawing no. 182 Rev. C – annotation referring to top rows (T1 and T3)

56.4. Working drawing no. 1112/W/HUH/ATK/C12/182 Rev. C dated 21
September 2015 (Image 7) clearly indicated two rows (T1 and T3) of T40 top layer rebars connecting the top of the east diaphragm wall to the EWL slab, with a spacing of 150 mm centre-to-centre. The coupler schedule in working drawing no. 1112/W/HUH/ATK/C12/607 Rev. B dated 16 June 2015 (Image 8) indicated the same detail.
