# **MTRCL Shatin to Central Link Contract 1112 Hung Hom Station & Stabling Sidings**

**Change of Details at Eastern Diaphragm Walls and Slabs**

<b>Project:</b>	MTRCL Contract SCL 1112, Hong Kong
<b>Report Title:</b>	Change of Details At Eastern Diaphragm Walls and Slabs
<b>Document No:</b>	H118026-TG-SGN-GF-RP-CB-0001
<b>Revision:</b>	0
<b>Filename:</b>	H118026-TG-SGN-GF-RP-CB-0001.doc

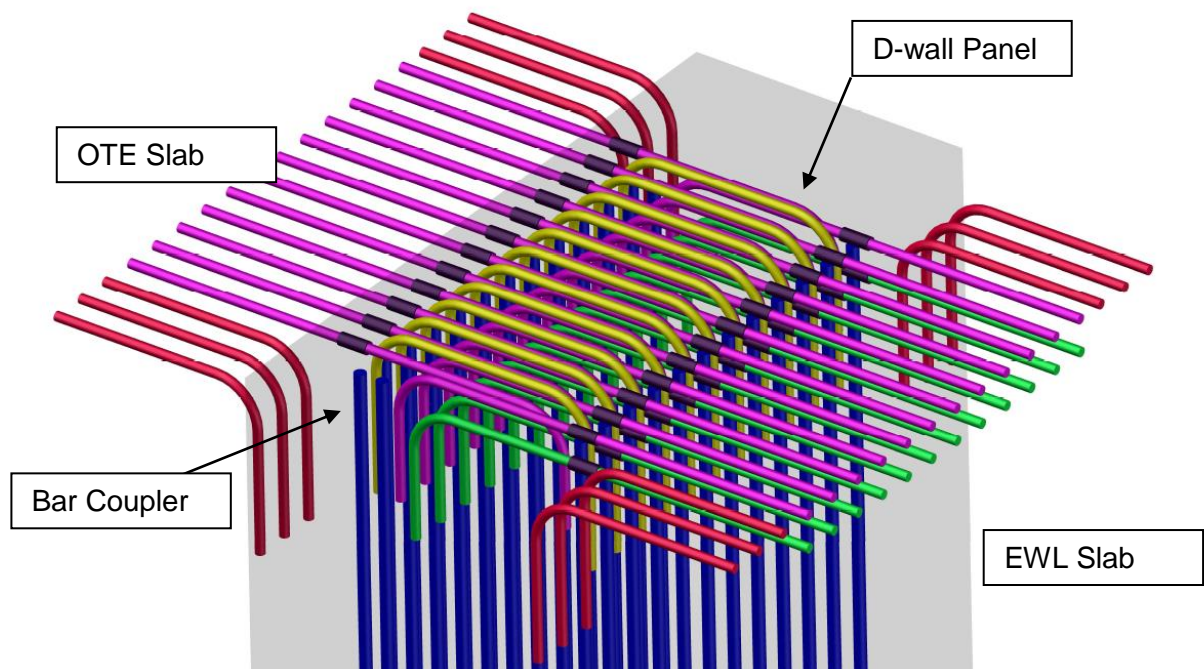
**Figure 4 – Typical Reinforcement Arrangement at D-wall / Slab Interface**

The reinforcement continuity of these T40 bars was to be provided using bar couplers, connecting to T40 L-shaped bars embedded into the top of the diaphragm walls at the level of the top and bottom of both slabs. Refer to the green and magenta coloured bars in Figure 4.

The contractor has to construct the d-wall panels using a 300mm diameter pipe (tremie pipe), which allows the concrete to be placed at the base of the panel to displace the supporting fluid (bentonite) in the open trench and therefore needs to be inserted into the top and centre of the panel. As can be seen in the Figure 4 above, there is no space at the top to allow a 300mm pipe to be inserted vertically into the reinforcement cage as the pipe clashes with the magenta, yellow and green reinforcement bars, which are spaced at 150mm centres.

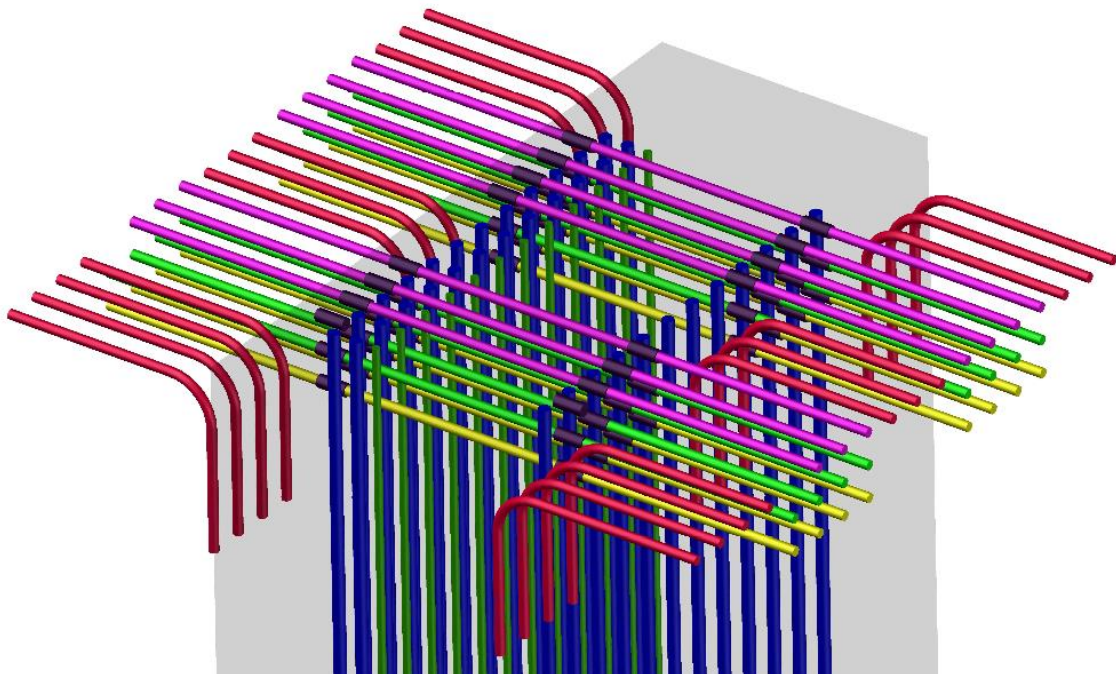
**Figure 5 – Revised Reinforcement Arrangement at D-wall / Slab Interface**

Of importance is that the magenta and green T40 bars are no longer turned down in the d-wall but are extended straight to the other face of the d-wall, with a bar coupler at each end and are arranged in two groups of 4 bars each, providing a clear space in the middle. There is also a

third layer of reinforcement shown in yellow, so that the total number of horizontal bars remains unchanged at 24 bars per panel. The u-bars at the top of the d-wall, shown in yellow in Figure 4, were deleted as they were no longer necessary with the design approach now adopted by Atkins.

The means by which anchorage of the bars from the EWL slab was achieved was by extending all of these bars into the OTE slab. The magenta, green and yellow bars are shown extending out of both sides of the d-wall in Figure 5 above.

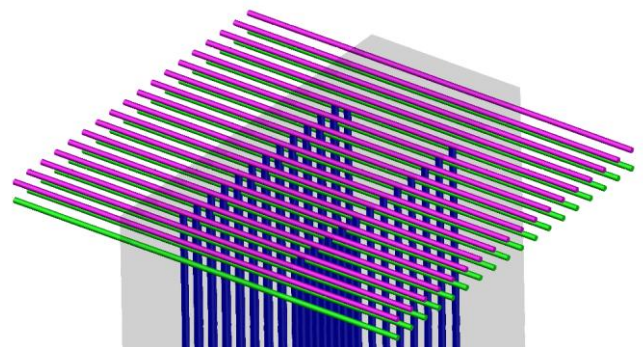
3. Two layers of T40 bars at 150mm centres, total 36 bars per panel, both rows continuous between EWL and OTE slabs

So in effect the as constructed situation is similar to the original design, except that the bar couplers were deleted and the amount of effective reinforcement was increased by using continuous bars across the top of the d-wall.

This approach allowed the contractor to remove the exposed bars and couplers and replace them with 2 layers of T40 bars at 150 spacing, the bars being continuous between the EWL slab, through the top of the d-wall and into the OTE slab without any couplers. Refer to Figure 9 below.

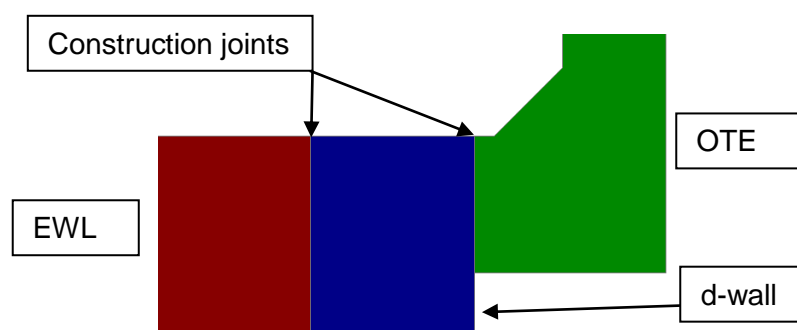
**Figure 11 – Construction Joints in Original and Revised Design**

In the original design and revised details, there was a vertical construction joint at the interface between d-wall and EWL slab and also between the d-wall and the OTE slab.

The HK Code of Practice places no restriction on the location of construction joints and by the nature of the staged construction of the d-wall and EWL/OTE slabs, the construction joints are unavoidable.

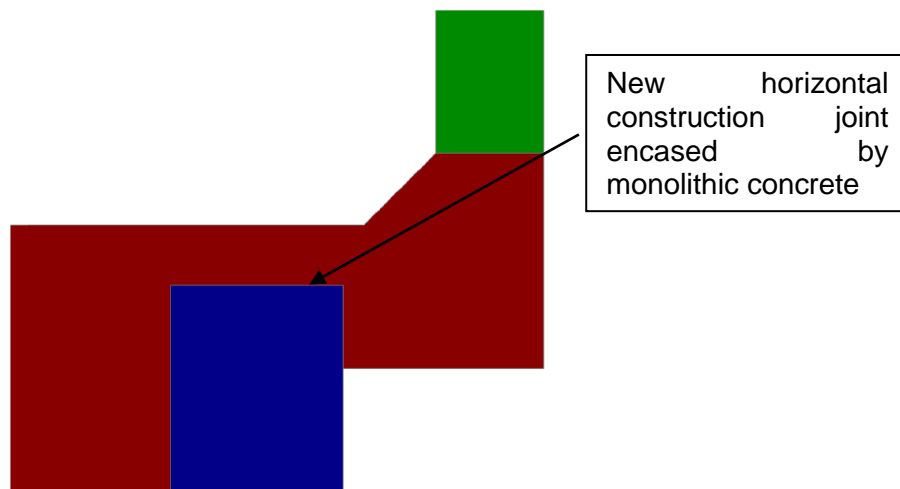
- The partial demolition and replacement of the top 420mm of the d-wall has no effect on the structural performance of the d-wall, and for the reasons explained in 9.5 above, the resulting outcome is more durable than the original detail because of the elimination of the vertical construction joints between the d-wall and the EWL and OTE slabs. The detail does introduce a horizontal construction joint introduced into the d-wall 420mm from the top surface of the slab, but this joint is fully encased in surrounding concrete and is therefore fully protected.

- This horizontal construction joint will have had no effect on the structural performance of the d-wall.
- The alteration of the main reinforcement of the slab has had no effect on its structural performance compared to the design accepted by BD for the following reasons:
  - The member sizes, sequence of construction of walls and slabs and all applied loadings are not altered by the change in reinforcement detail. Thus the bending moments and shear forces in the EWL and OTE slabs and the d-wall remain unchanged, so there is no change in load path and the manner in which the structure responds to the applied loadings.
