**COMMISSION OF INQUIRY INTO THE DIAPHRAGM WALL AND PLATFORM
SLAB CONSTRUCTION WORKS AT THE HUNG HOM STATION EXTENSION
UNDER THE SHATIN TO CENTRAL LINK PROJECT**

**REPLY WITNESS STATEMENT OF WONG CHI CHIU
FOR
MTR CORPORATION LIMITED**

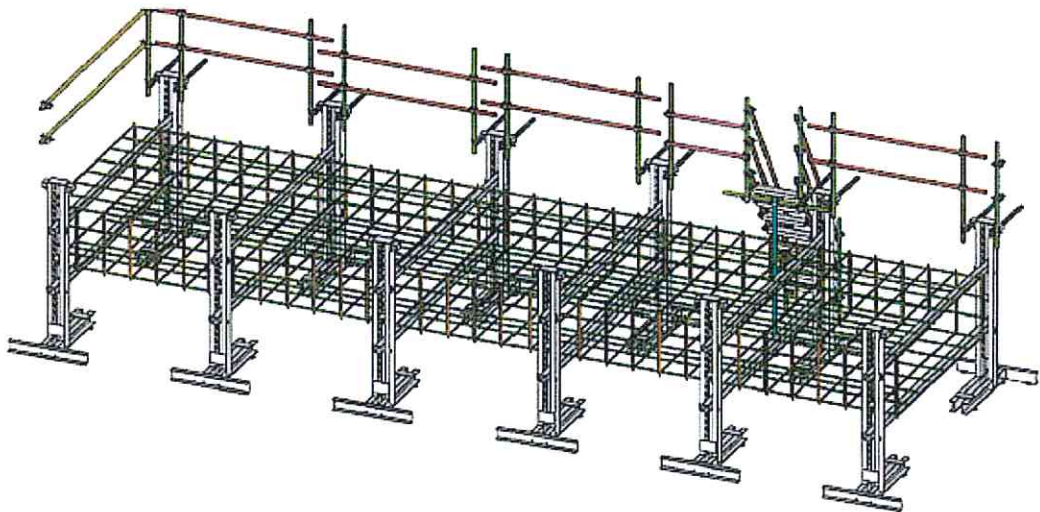
Image 1: Method Statement figure 6.10.2.1 showing L-frame workbench

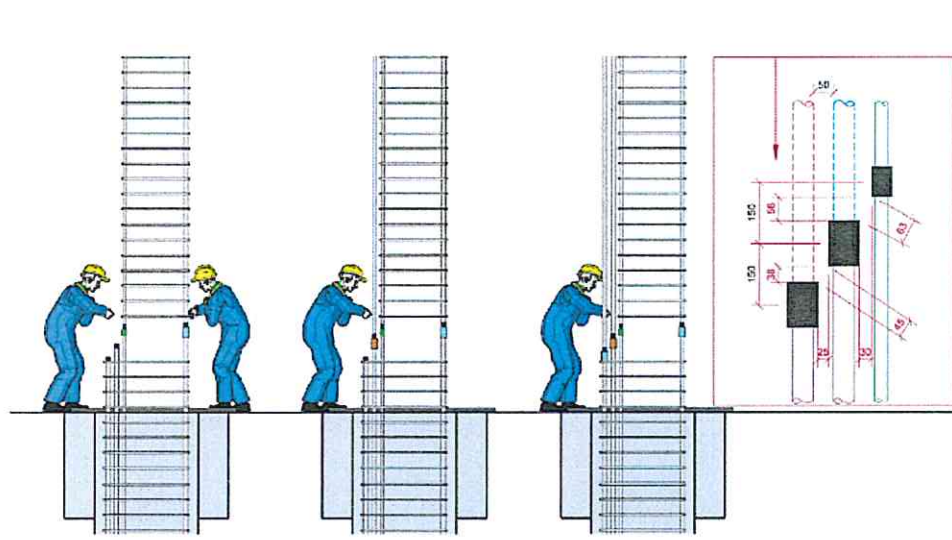
- **OPTION 1 –**

- There is good access for steel fixers to tighten the couplers and spacing bars provides good support to help positioning the bars better alignment.
- However usage of this option is restricted because of the presence of many starter bars. Fitting reinforcement layer through the starter bars may be difficult and bring damages to starter bar couplers.

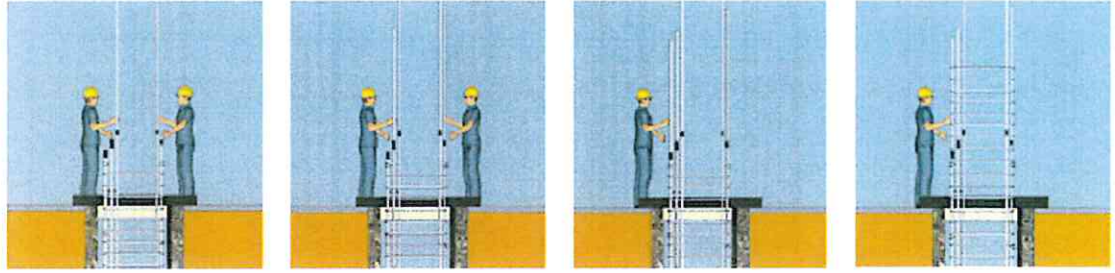
- **OPTION 2 –**

- There is no access problem for steel fixers to tighten the vertical coupler bars and spacing bars.
- This alternative is believed involves more in-situ tightening compare to option 1. However, more flexibility has provided on install horizontal starter bars together with the main bars tightening.

Image 4: figure in Method Statement showing splicing option 2
