**COMMISSION OF INQUIRY
INTO THE CONSTRUCTION WORKS
AT AND NEAR THE HUNG HOM STATION EXTENSION
UNDER THE SHATIN TO CENTRAL LINK PROJECT
 (“the SCL Project”)
 (“THE COMMISSION”)**

**CLOSING ADDRESS FOR THE EXTENDED INQUIRY
BY COUNSEL FOR THE COMMISSION**

**(in respect of the Substantive Hearing commencing on 27 May 2019 and
concluding on 17 June 2019 and convened to hear the factual evidence
concerning the Extended Inquiry)**

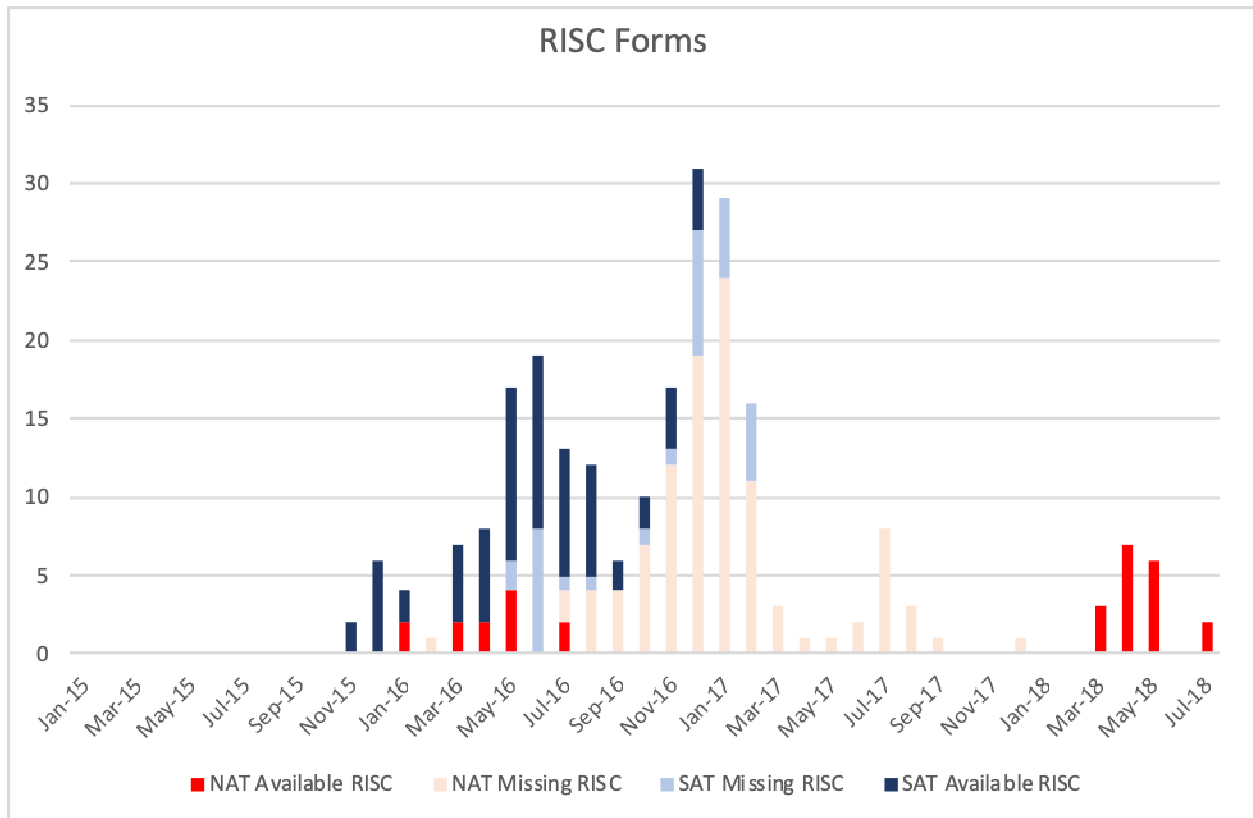
Chart 1 – NAT and SAT

155. It can be seen from the bar charts¹⁵² below that there was a trend of deterioration starting mid-2016. There was an obvious increase in the numbers and percentage of missing RISC forms at NAT and SAT after Mr. Kit Chan left the project and Mr. Michael Fu took over as Construction Manager:-
