**COMMISSION OF INQUIRY
INTO THE DIAPHRAGM WALL AND PLATFORM SLAB
CONSTRUCTION WORKS
AT THE HUNG HOM STATION EXTENSION
UNDER THE SHATIN TO CENTRAL LINK PROJECT
("THE COMMISSION")**

CLOSING ADDRESS BY COUNSEL FOR THE COMMISSION

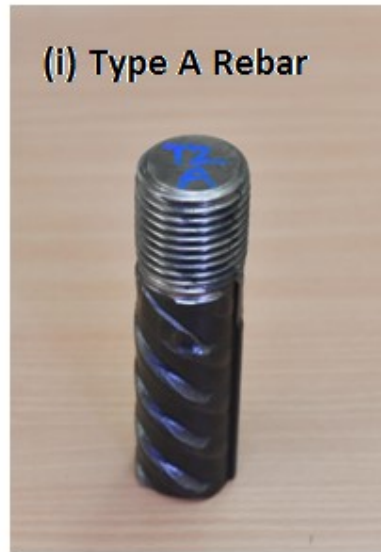
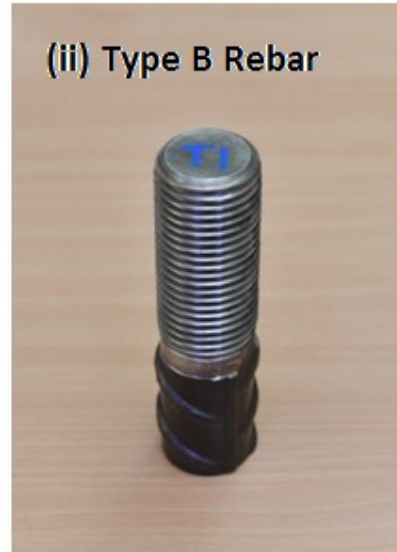
14. For present purposes, there are two types of rebar and two types of coupler. As to the rebar, Type A rebar has approximately ten/eleven (10/11) threads, whilst Type B rebar has approximately twenty/twenty-one (20/21) threads, or almost twice as many threads as Type A. As to the couplers, both Type I and Type II can be ductile (a Seisplice coupler) or non-ductile (a Servisplice coupler) and they can be distinguished by their visual appearance, the ductile/Seisplice coupler having a distinct shiny ring at each end and the non-ductile/Servisplice coupler having a uniform dark appearance. As to functionality, Type I is referred to as a “standard” coupler and is used when threaded rebar is to be severed into the coupler (at both ends). Type II is referred to as a “positional” coupler and is used in situations where the individual steel bars of pre-fabricated rebar cannot be rotated (because, for example, it is L-shaped at one end). In this situation the coupler itself is rotated and subsequently counter-rotated. The four photographs below show (i) Type A rebar, (ii) Type B rebar, (iii) non-ductile coupler (T1) and (iv) ductile coupler (T2).
