**COMMISSION OF INQUIRY INTO THE DIAPHRAGM WALL AND
PLATFORM SLAB CONSTRUCTION WORKS AT THE HUNG HOM STATION
EXTENSION UNDER THE SHATIN TO CENTRAL LINK PROJECT**

**WITNESS STATEMENT OF HO HO PONG JAMES
FOR
MTR CORPORATION LIMITED**

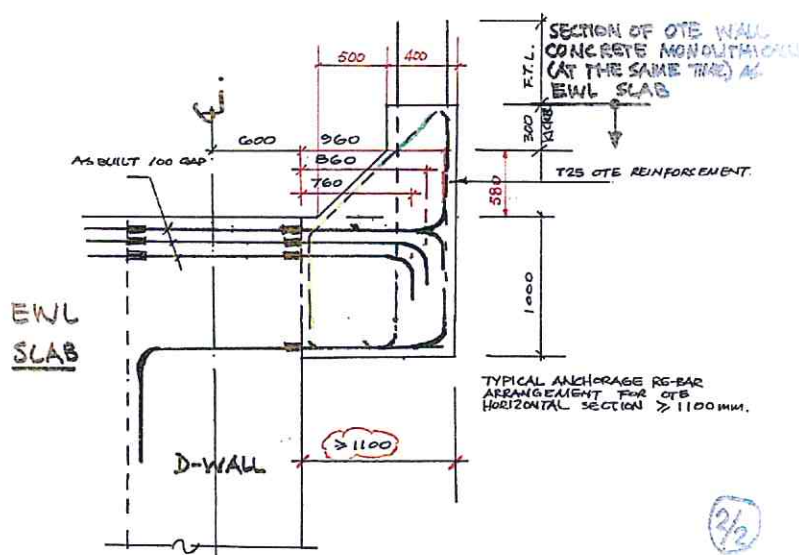
Image 3: extract from drawing attached to Atkins B's response to LCAL's TQ 33.
