## COMMISSION OF INQUIRY INTO THE CONSTRUCTION WORKS AT AND NEAR THE HUNG HOM STATION EXTENSION UNDER THE SHATIN TO CENTRAL LINK PROJECT

## WITNESS STATEMENT OF FU YIN CHIT FOR MTR CORPORATION LIMITED

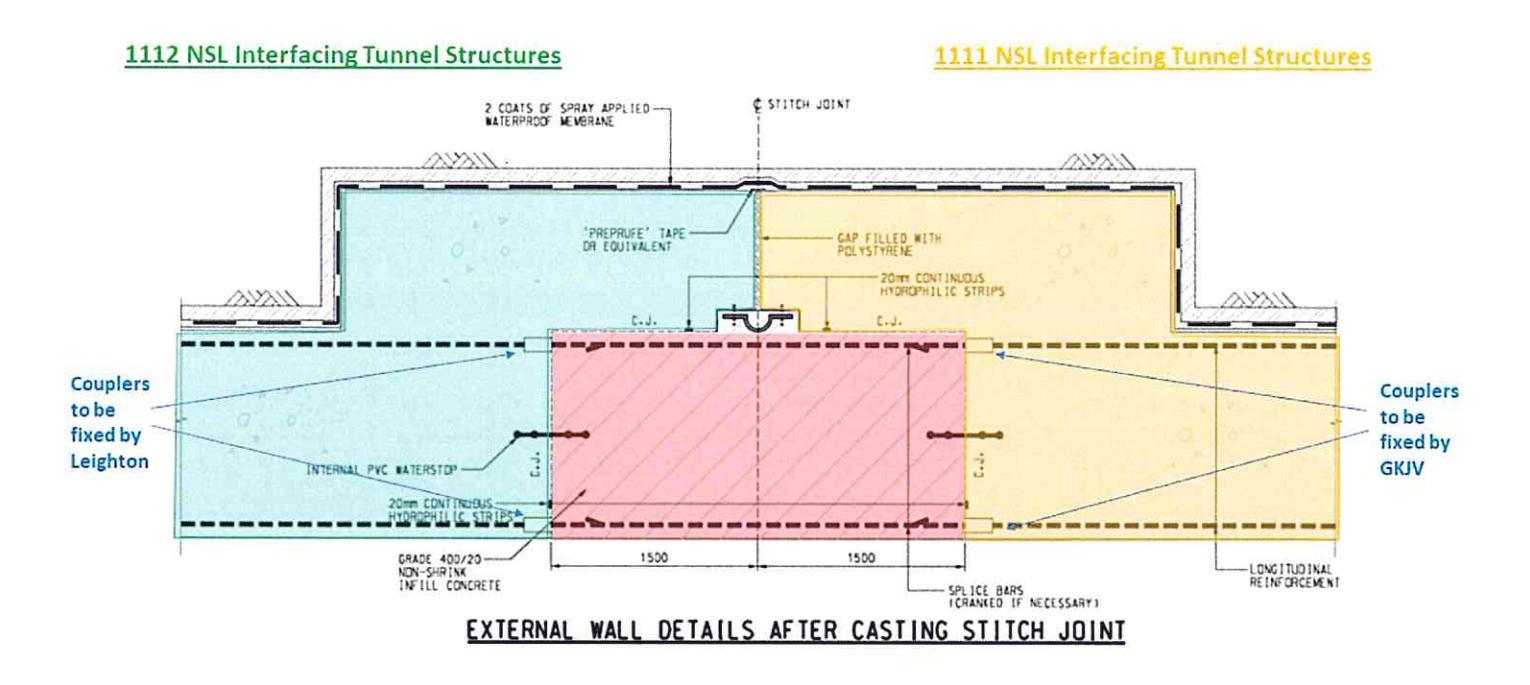
#### **Diagram 1: Typical Details of a Stitch Joint (External Walls)**<sup>8</sup>

15. The diagram below shows the typical details of a stitch joint connecting the external walls of the interfacing tunnel structures at NAT as shown in working drawing no. 1112/W/000/ATK/C11/102.<sup>6</sup> The roof and base slabs follow similar typical details (see their typical details at working drawings nos. 1112/W/000/ATK/C11/101<sup>7</sup>). I will briefly explain the steps and procedures involved in the construction of the 1111/1112 NSL Stitch Joint by reference to it:

- (a) First, GKJV should construct the 1111 NSL Interfacing Tunnel Structures with couplers (with protective caps) fixed at the end of the structure. Note that there should be a collar at the exterior of the structure. GKJV should also install a waterproof membrane at the exterior of the collar and a water stop at the structure. See the <u>vellow</u> parts of the diagram (see <u>Appendix D</u> for an enlarged version of Diagram 1).

- (b) Then, Leighton should construct the 1112 NSL Interfacing Tunnel Structures also with couplers (with protective caps) fixed at the end of the structure. There should also be a collar at the exterior of the structure. Leighton should also install a waterproof membrane at the exterior of the collar and a water stop at the structure. See the <u>green</u> parts of the diagram (see <u>Appendix D</u> for an enlarged version of Diagram 1).

- (d) At the stage of construction referred to in sub-paragraph (c) above, the two collars at the exteriors of the structures would serve the purpose of sealing up the space within the tunnel structures (i.e. the red part as shown in Diagram 1) before the two structures were "stitched" together. As there would still be a gap between the collars (through which soil and underground water might seep in after backfilling and the recharging of underground water had occurred), Leighton was required to install an omega seal at the inner intersection of the two collars.

- (e) After the differential movements of the two structures were stabilised, Leighton should:
  - Expose the couplers fixed at the 1111 NSL Interfacing Tunnel Structures and screw rebars (the "1111 rebars") into those couplers;
  - (ii) Expose the couplers fixed at the 1112 NSL Interfacing Tunnel Structures and screw rebars (the "1112 rebars") into those couplers; and
  - (iii) Lap the 1111 rebars with the 1112 rebars at their intersections (and, hence, form what is referred to as a "stitch" joint).

See: the part in <u>red</u> in Diagram 1 above (see <u>Appendix D</u> for an enlarged version of Diagram 1). The black dotted lines therein represent the lapping of the 1111 rebars with the 1112 rebars. To illustrate such lapping more clearly, I have prepared the following diagram, which is the "zoomed-in" version of Diagram 1 above focusing on the red part. Instead of using black dotted lines, <u>bright yellow</u> lines are used to represent the 1111 rebars, and <u>bright green</u> lines are used to represent the 1112 rebars.

<sup>&</sup>lt;sup>6</sup> Note that some of the dimensions and details in Diagram 1 had been revised by DAmS/1112/C/0390, but this diagram serves as an illustration of how a stitch joint is typically built.

<sup>&</sup>lt;sup>8</sup> An enlarged version of Diagram 1 is at <u>Appendix D</u>
